# Back On The Road: Emergency Highway Restoration After A Hurricane

# US 98 (Franklin County) Soft Armor Countermeasures Utilizing Polymer Technology (Case Study)

Josh Boan, FDOT EMO

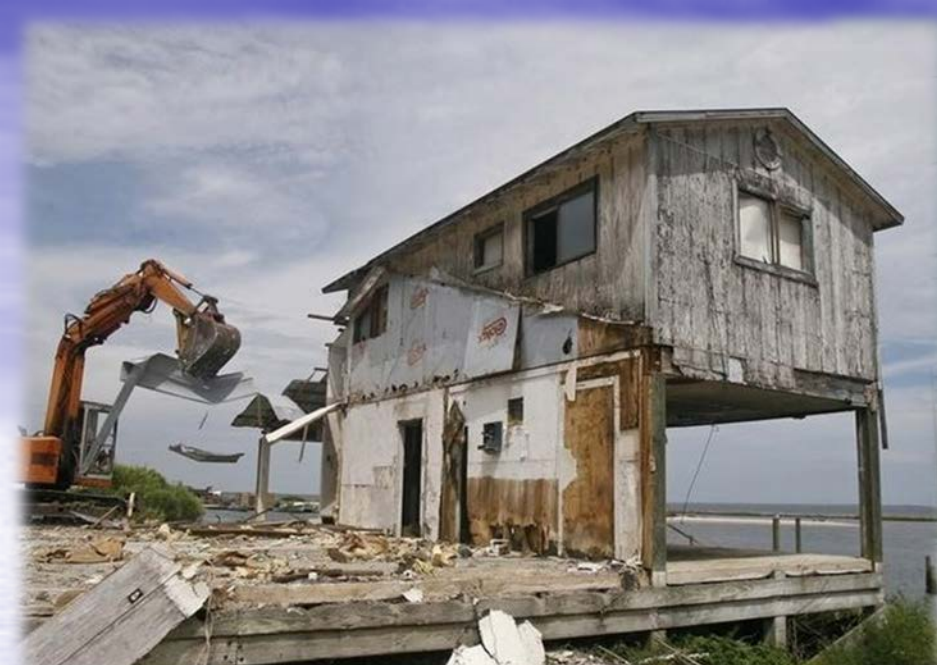
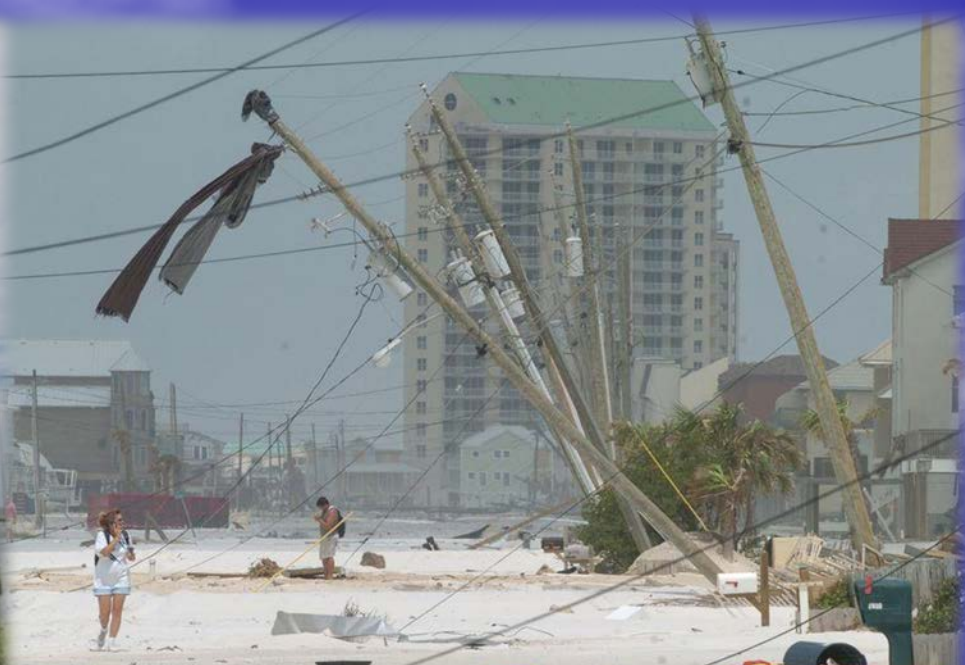
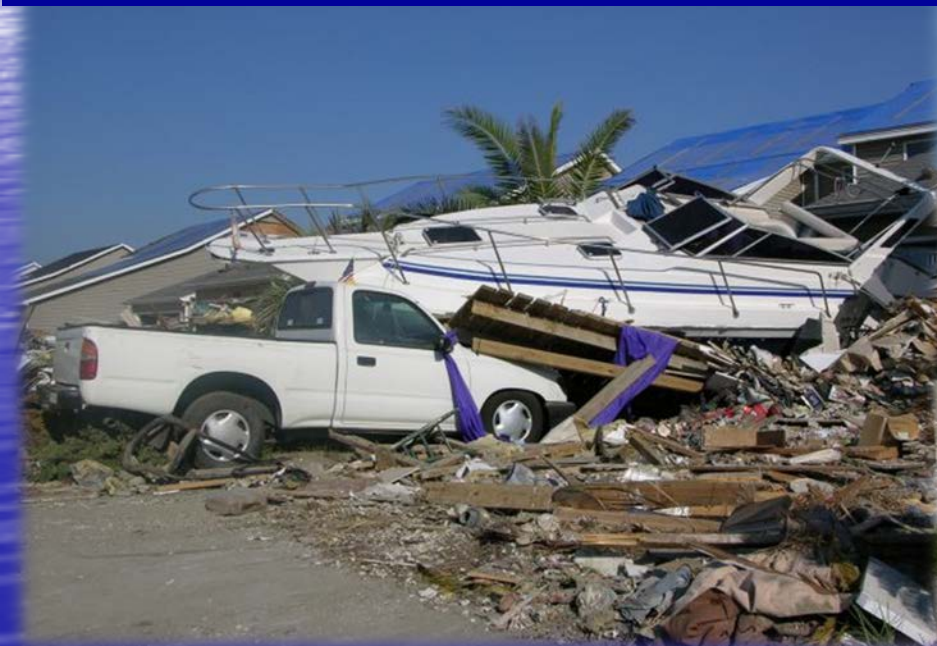
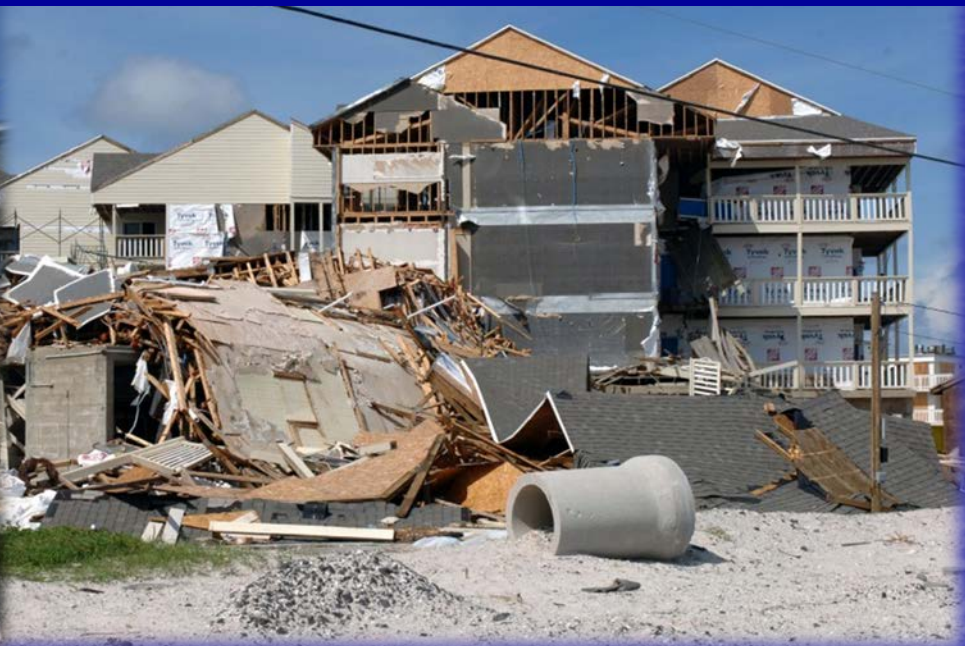
Severe structural damage to coastal dwellings.

## Structural Damage From Hurricane Dennis

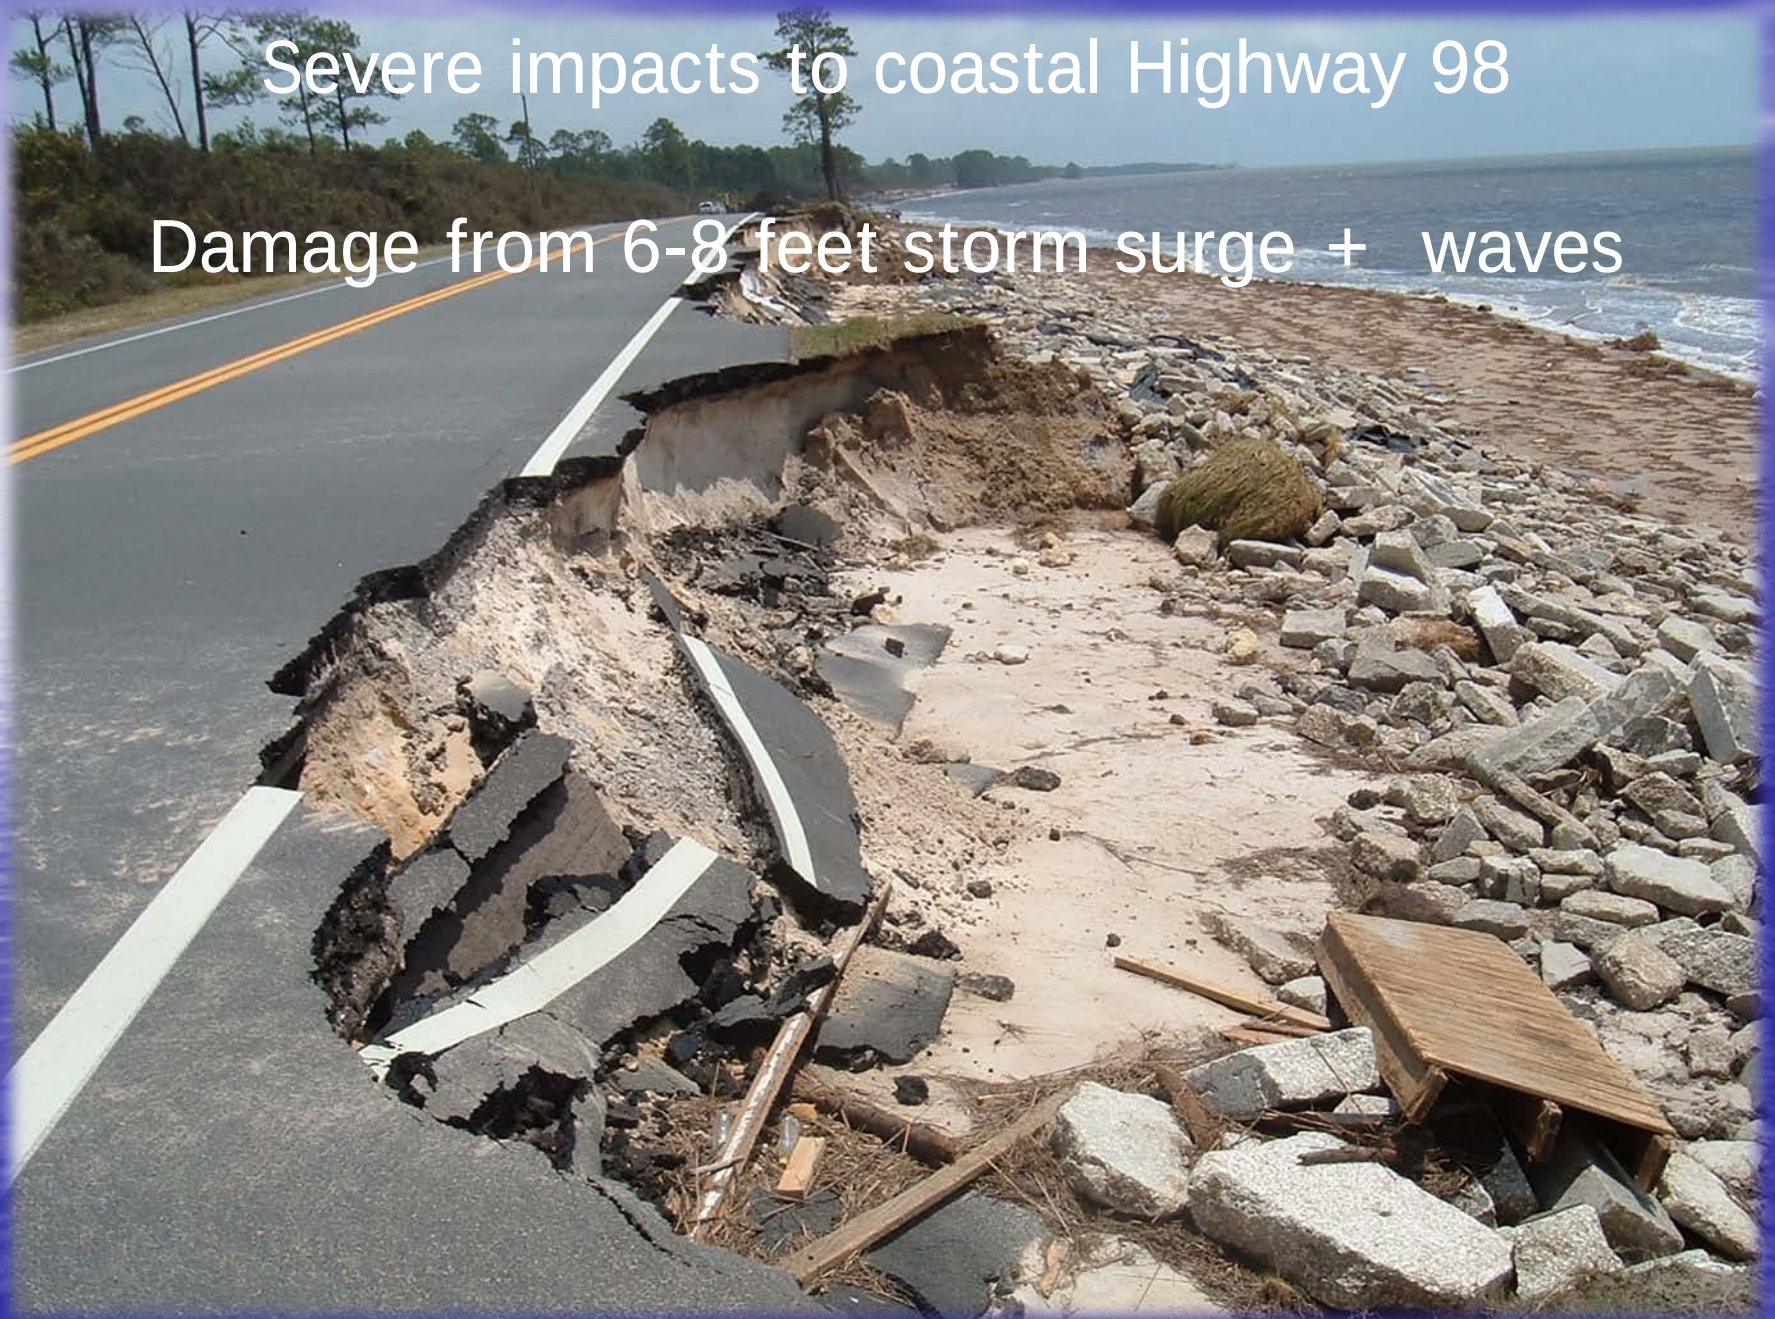
Severe impacts to coastal Highway 98

Damage from 6-8 feet storm surge + waves

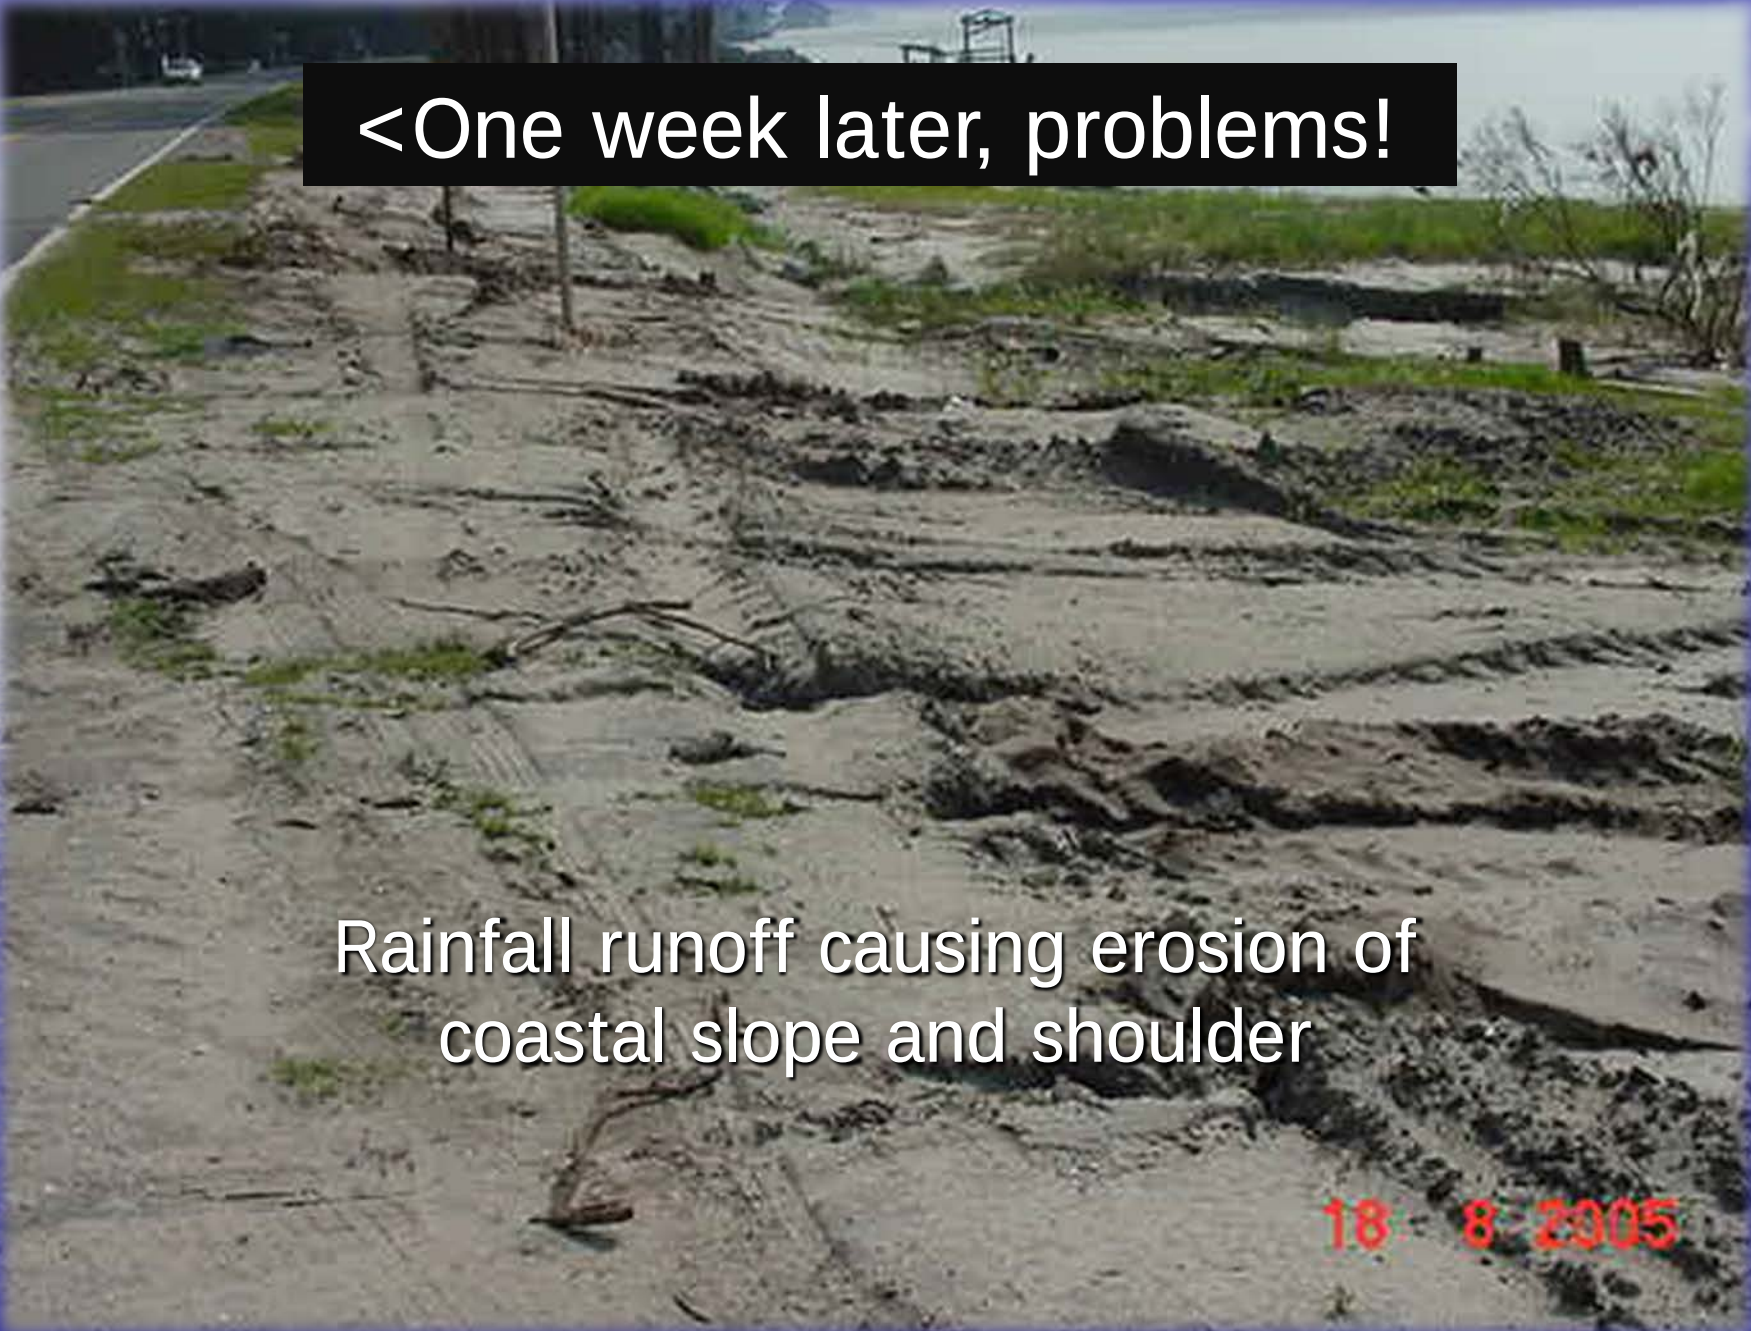
<One week later, problems!

Rainfall runoff causing erosion of  
coastal slope and shoulder

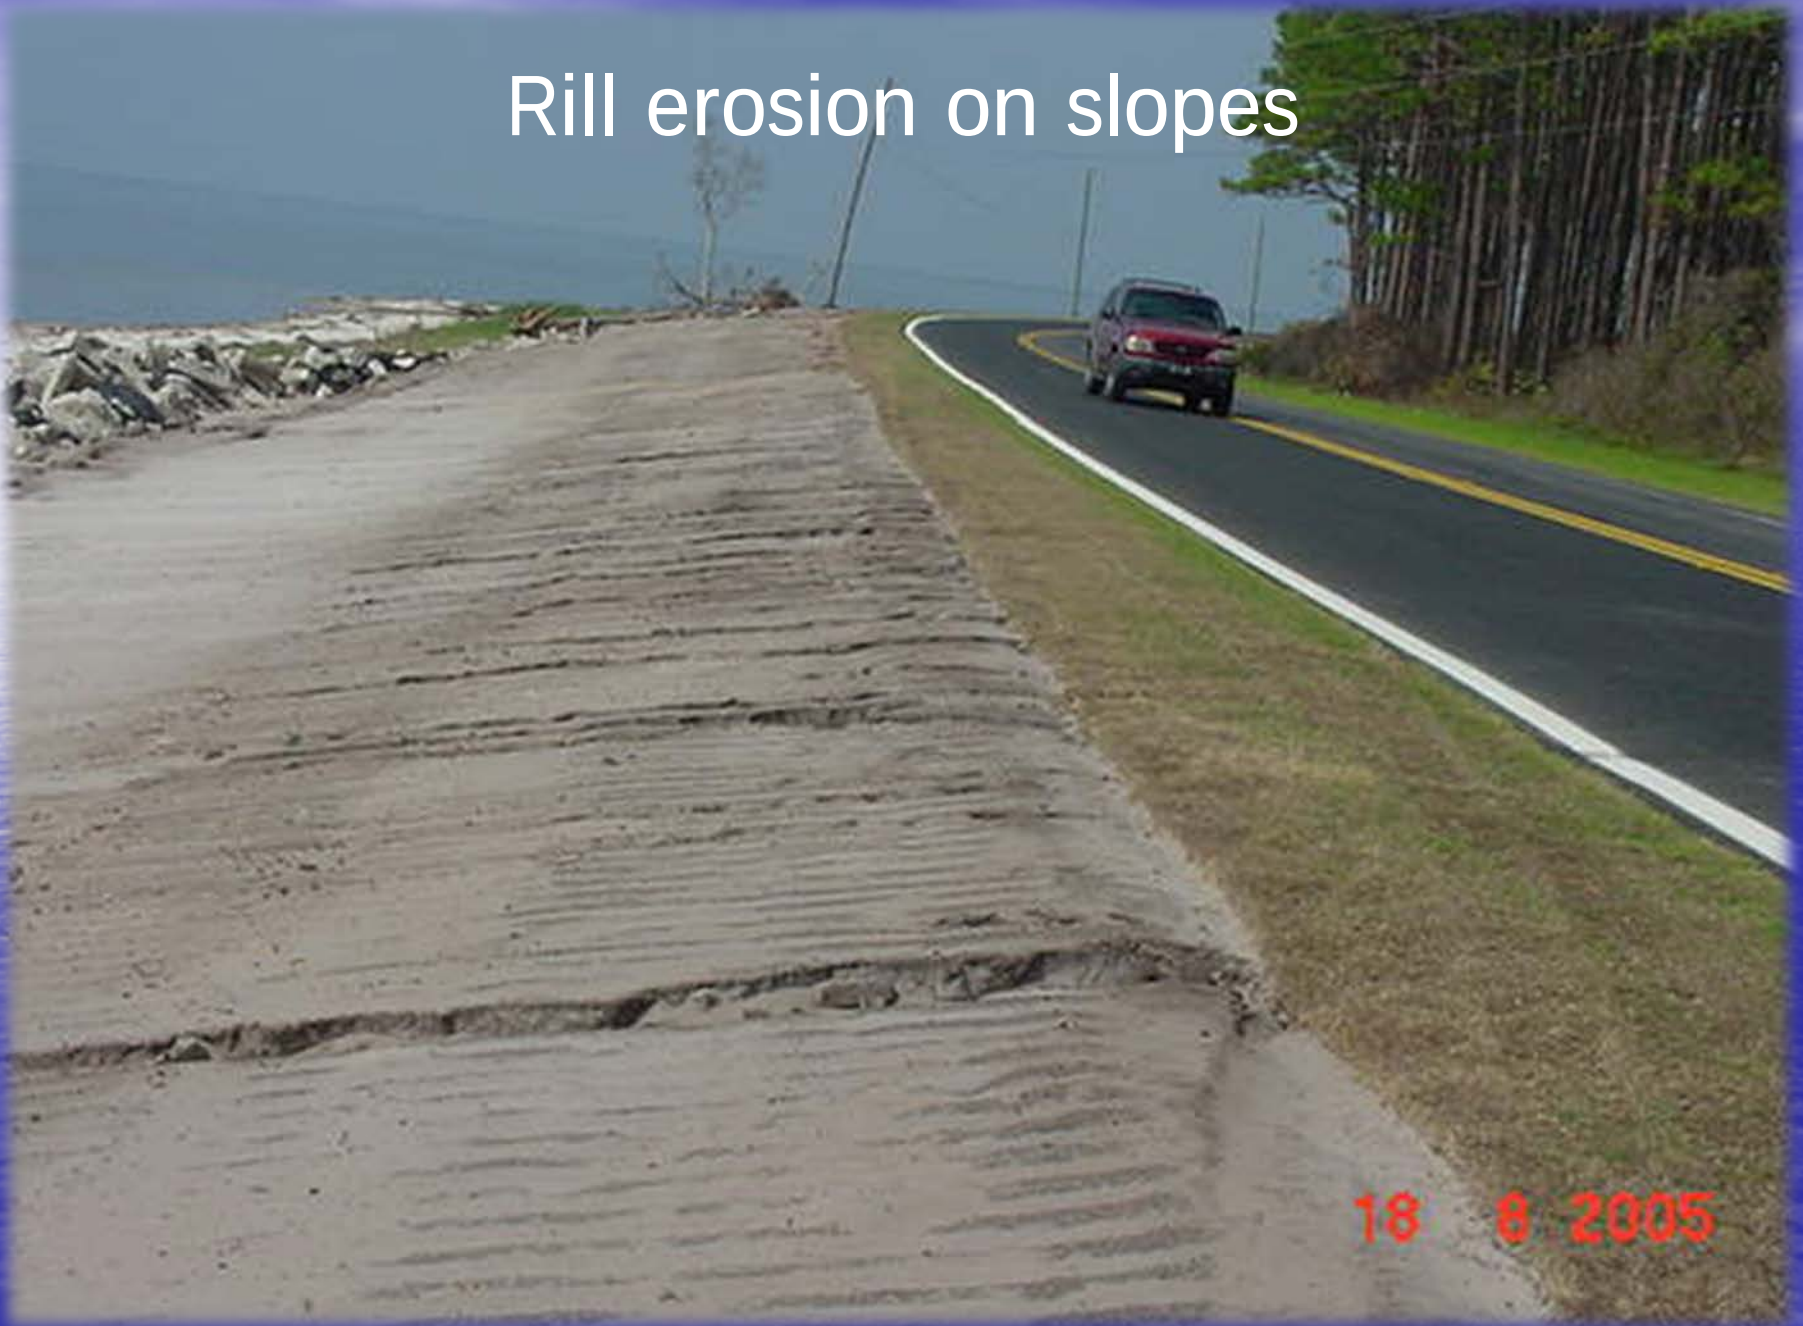
# Rill erosion on slopes

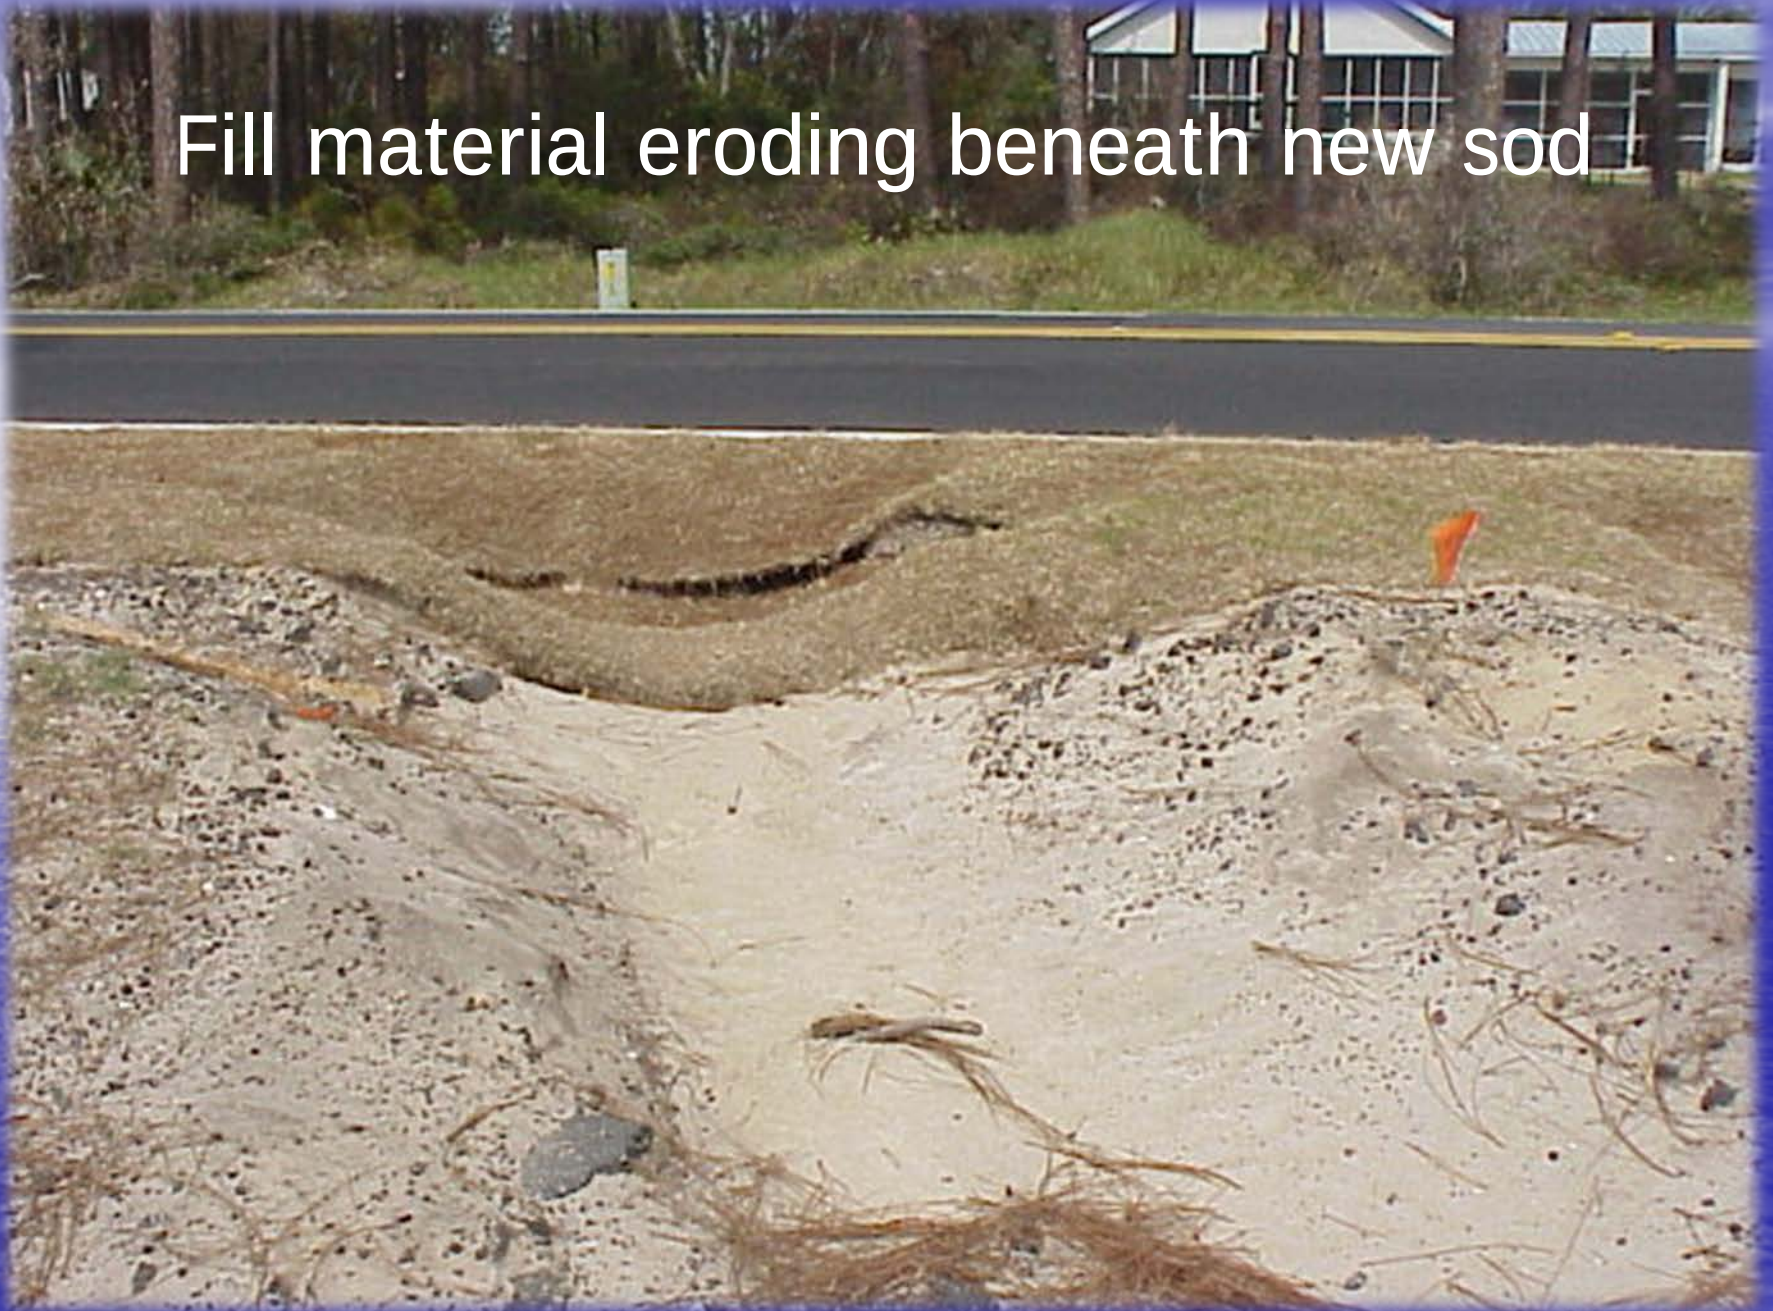
Fill material eroding beneath new sod

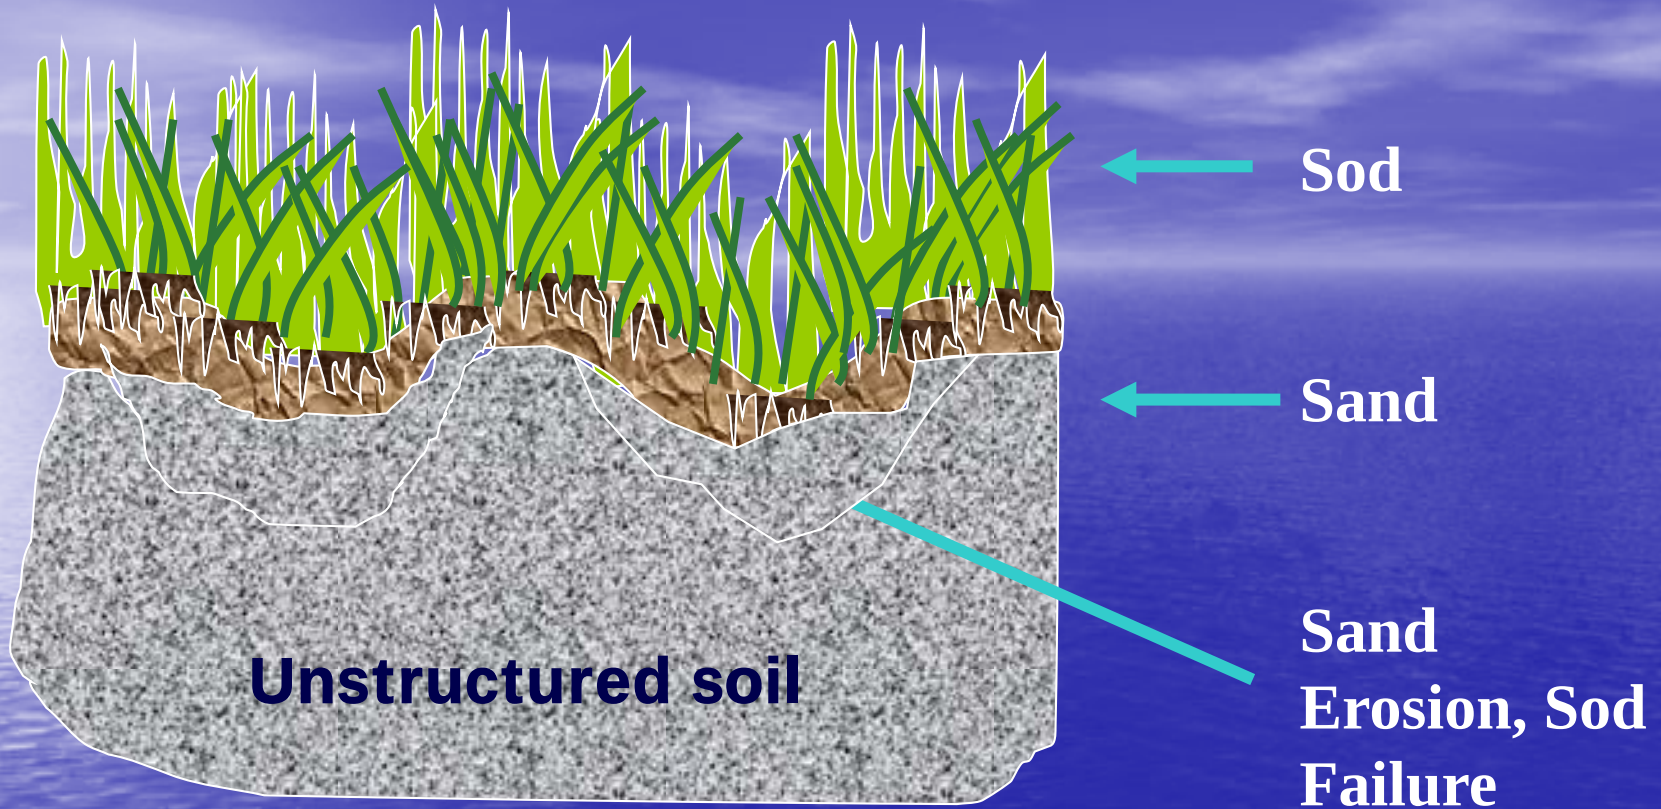
Sod installation on sand failed shortly after repair due to unstructured soil exposed to inundation. Sod roots failed to penetrate for stabilization of soil.

Stormwater inundated loose, unstructured soil which separated from sod causing erosion failure

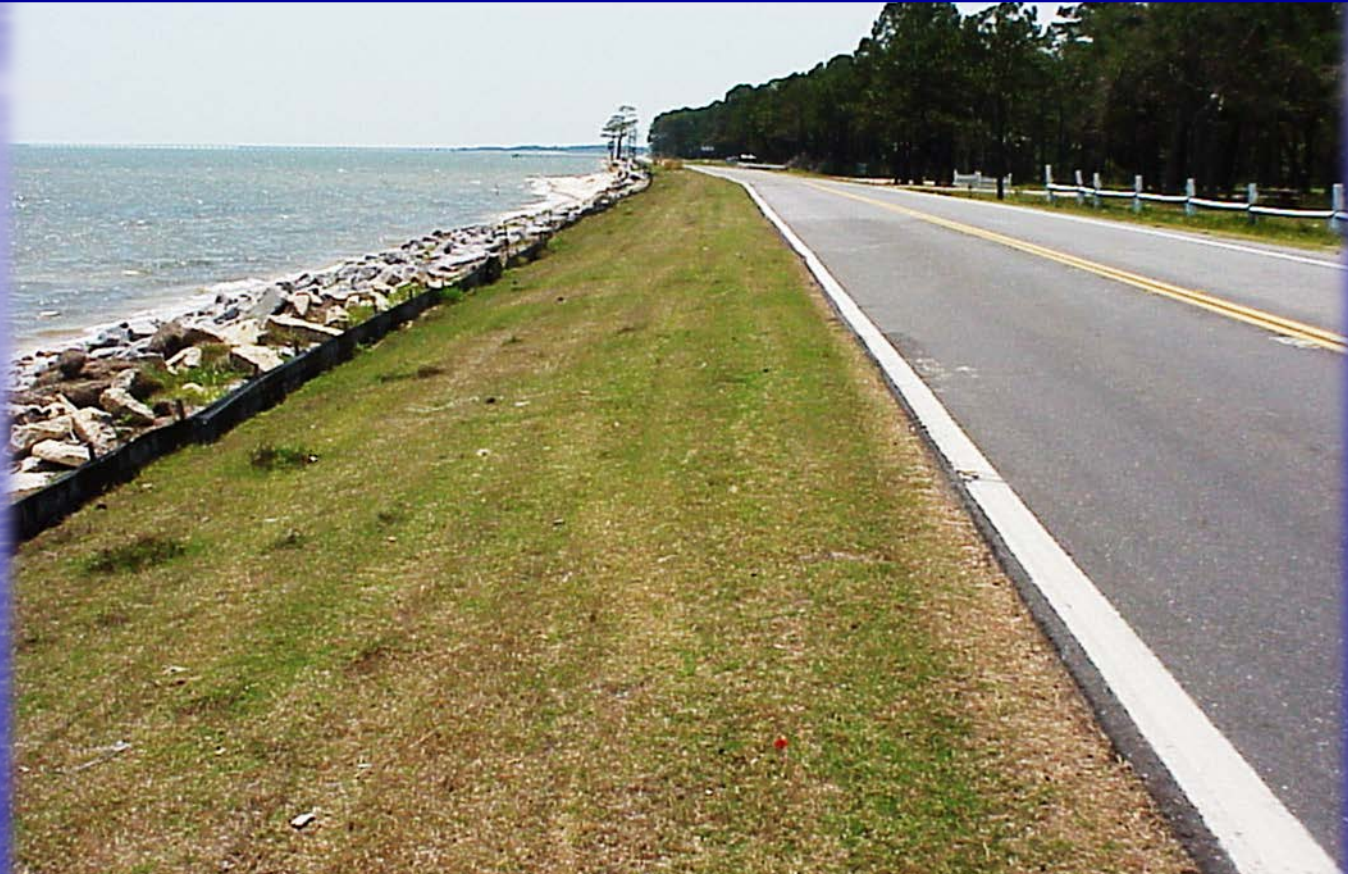
**One year after placement showed no erosion or need for further repair. This area was hit by a tropical depression and a category 1 hurricane within 100 days after initial installation.**

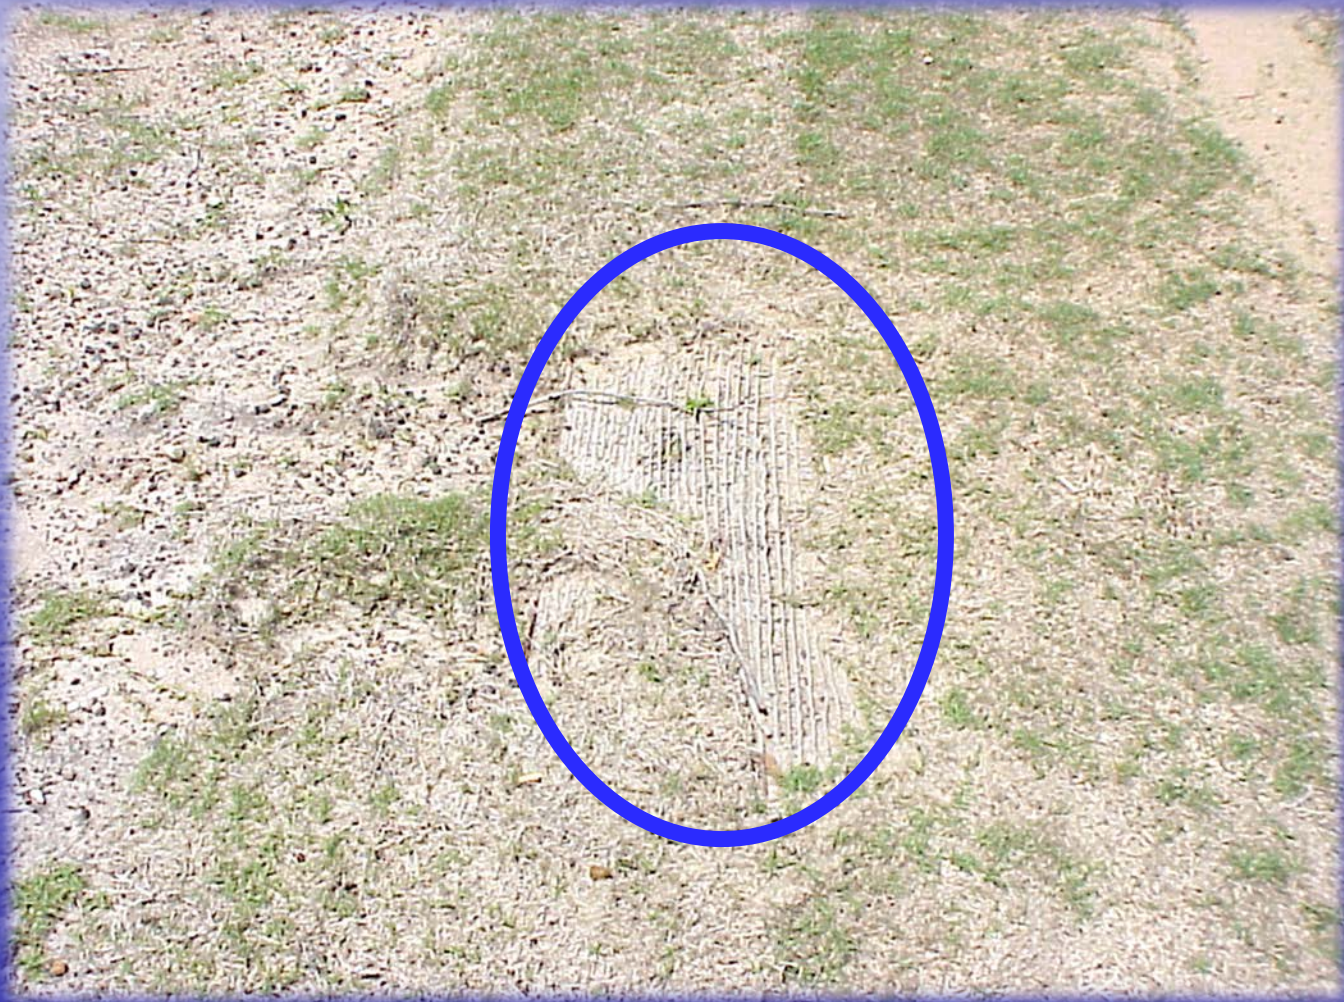
**The agglomerated matrix held even after  
sod wear by traffic**
