Hawaii State Department of Transportation  
Highways Division, Oahu District  
Storm Water Management Program  
NPDES Permit No. HI S000001  
April 2015

# **Action Plan to Address Erosional Outfalls**

**State of Hawaii Department of Transportation  
Highways Division, Oahu District**

April 2015  
Version: Final

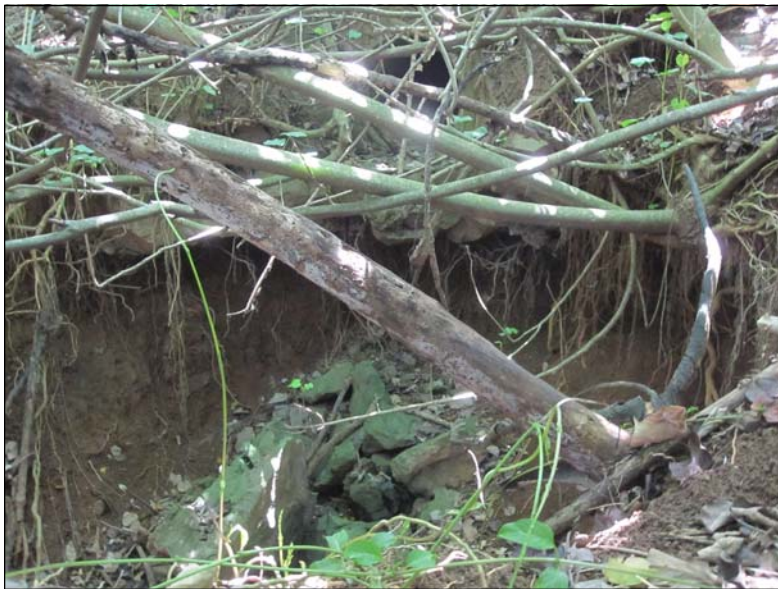
PID 300350 is an outfall for several catch basins that collect storm water along the H-3 Freeway near Kaneohe. The existing CRM headwall and apron is severely undercut and there are significant signs of erosion and sediment transport downstream of the outfall location.

**Photo 1: Undercut headwall and apron**

New concrete headwall and riprap apron.

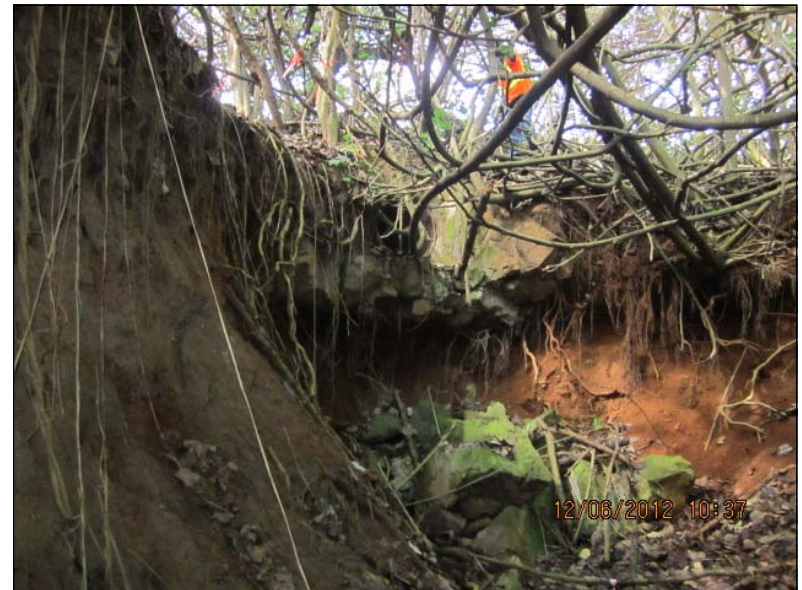
**Photo 2: Outfall erosion**

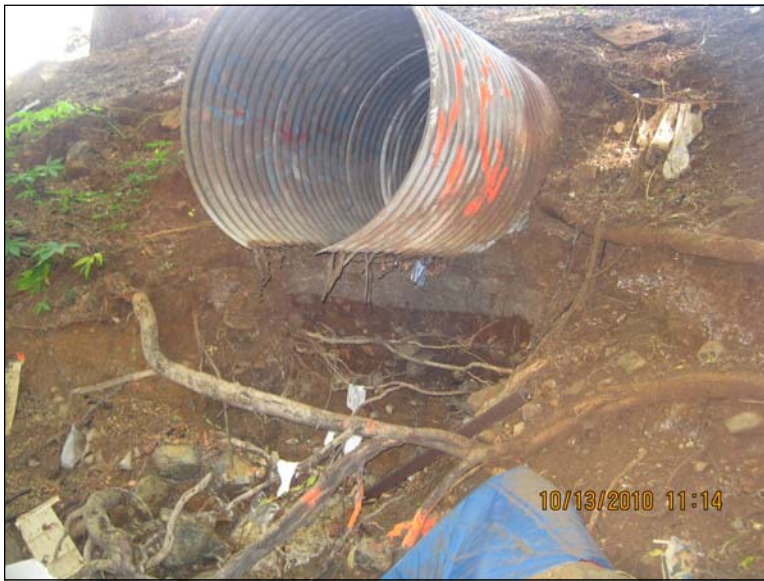
PID 302311 is an outfall that drains a network of several catch basins that collect storm water from the H-1 Freeway in Aiea. The CMP is corroded and there is significant erosion below the outfall, which is located directly on the bank of Aiea Stream.

**Photo 1: Corroded CMP outfall**

CMP pipe repair and new riprap apron.

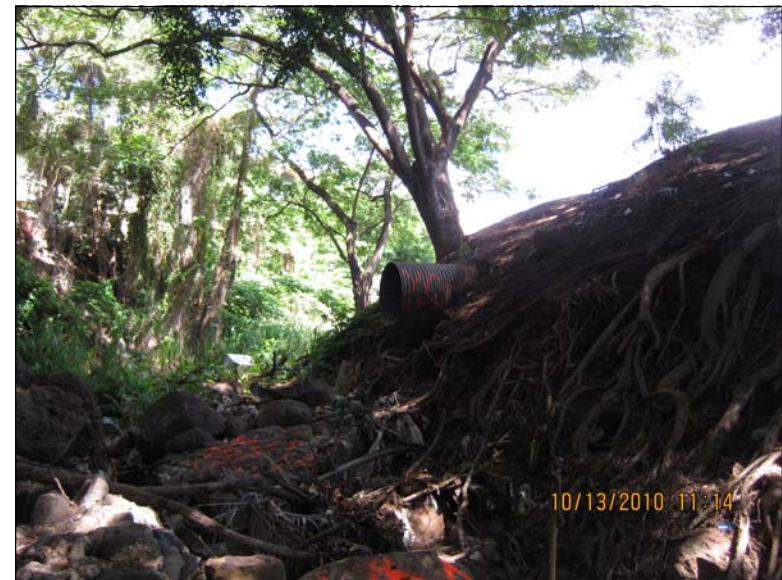
**Photo 2: Outfall stream bank erosion**

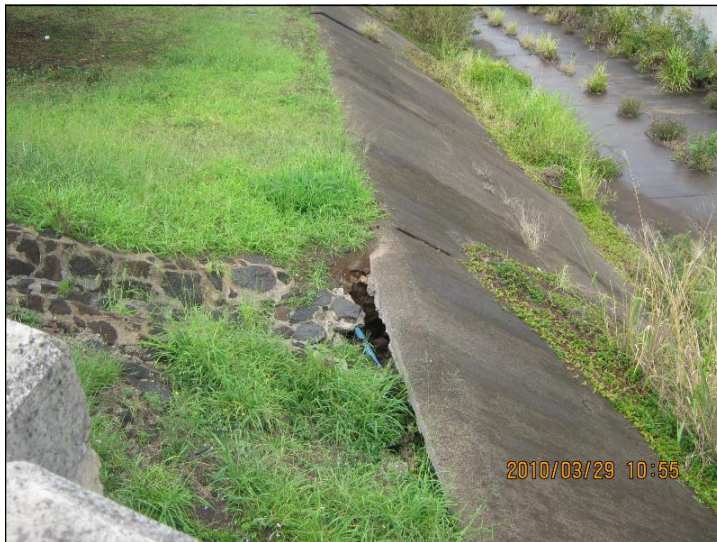
PID 302481 is a CRM spillway outfall that drains the shoulder of the H-1 Freeway directly onto the concrete lined stream bank of Halawa Stream. A gap has formed between the end of the spillway and the stream bank allowing storm water to erode sediment from the area behind the concrete stream channel liner.

**Photo 1: CRM spillway to concrete lined channel**

Control Density Fill (CDF) or epoxy behind eroded concrete lined stream bank and re-connect outfall apron to concrete stream bank.

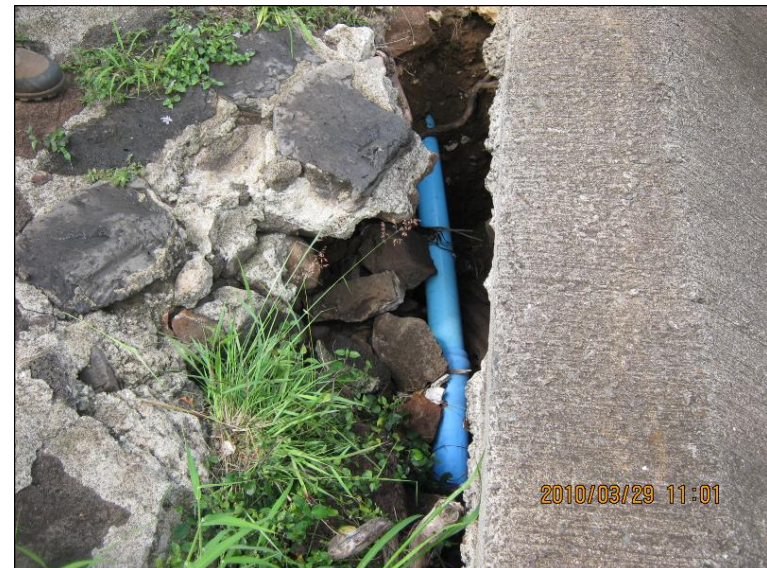
**Photo 2: Eroded area behind concrete liner**

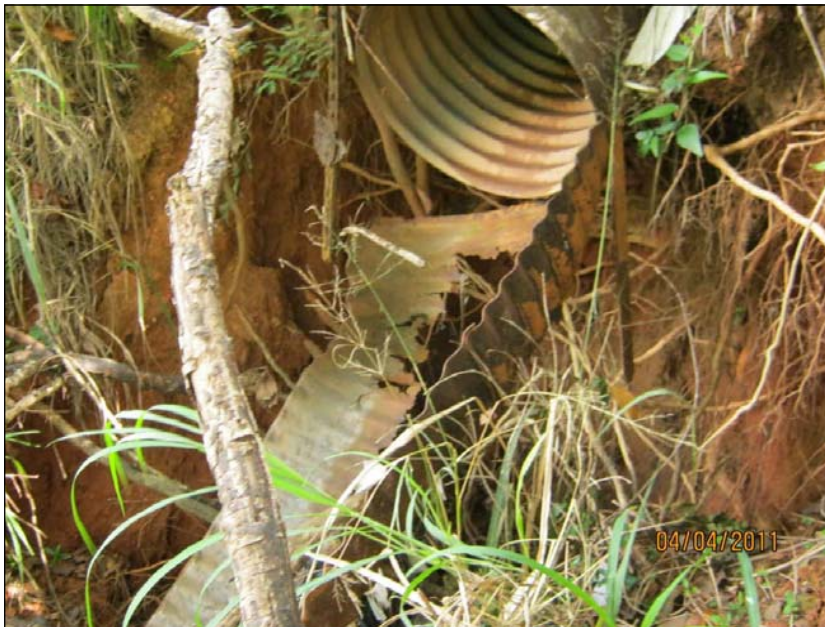
PID 301161 is a 24" CMP outfall that receives storm water flow from open channels and catch basins located along Kalanianaʻole Highway near Kailua. The CMP is severely undermined and collapsing and there is significant erosion downstream of the outfall.

**Photo 1: Pipe undermined due to erosion**

New concrete headwall and riprap apron.

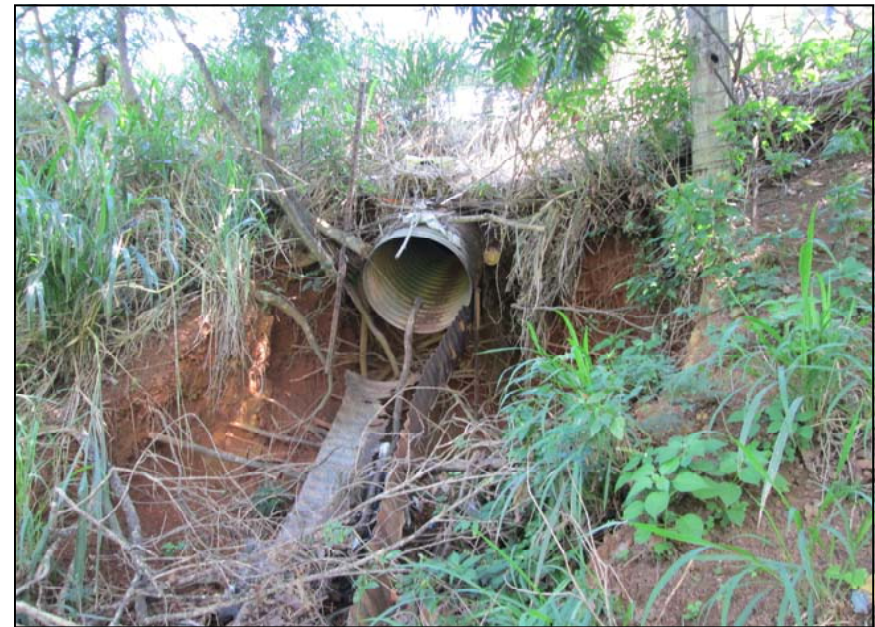
**Photo 2: Outfall erosion**

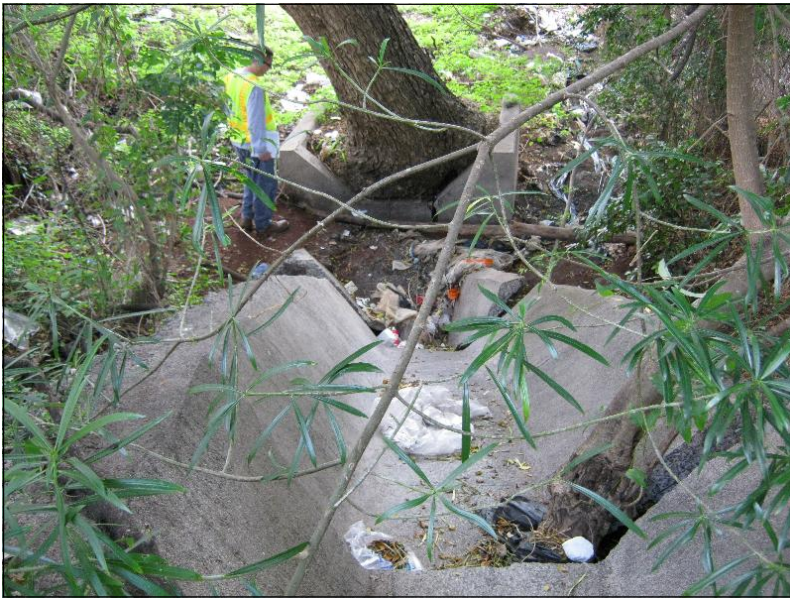
PID 301782 is a concrete open channel outfall that receives storm water runoff from catch basins and open channels located along the H-1 Freeway near Moanalua Road. The concrete channel is breaking apart in several locations and there is significant erosion at the outfall with sedimentation downstream of the outfall.

**Photo 1: Failing concrete liner at outfall**

Repair of concrete channel and outfall stabilization.

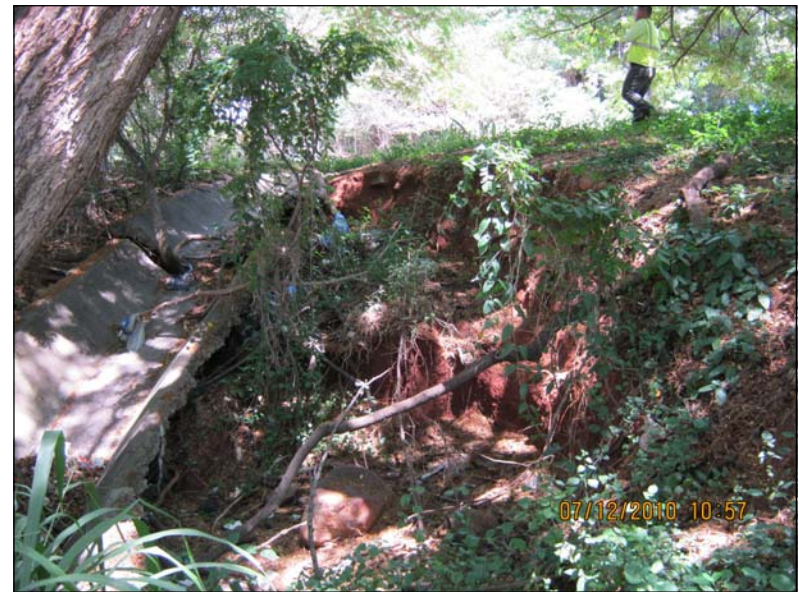
**Photo 2: Erosion at outfall**
