# Action Plan to Address Erosional Outfalls

State of Hawaii, Department of Transportation  
Highways Division, Oahu District  
SWMP, February 2022

# STORM WATER MANAGEMENT PROGRAM ACTION PLAN TO ADDRESS EROSIONAL OUTFALLS

MS4 NPDES Permit No. HI S000001

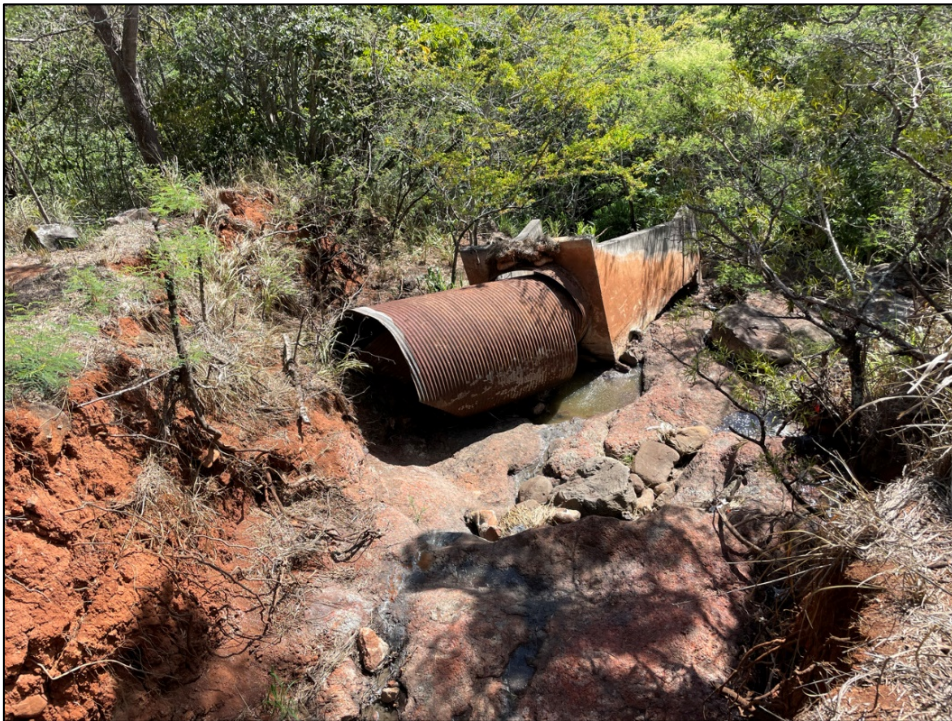
**Outfall Description:** PID 300732 is an outfall that drains a network of several catch basins that collect storm water from a residential neighborhood across the H-2 Freeway in Waipio. Heavy flow has eroded the surrounding soil and undermined the outlet headwall structure to the extent that it has separated from the rest of the culvert.

**Failed concrete outlet structure downstream of outfall**

New concrete outlet structure and outfall stabilization.

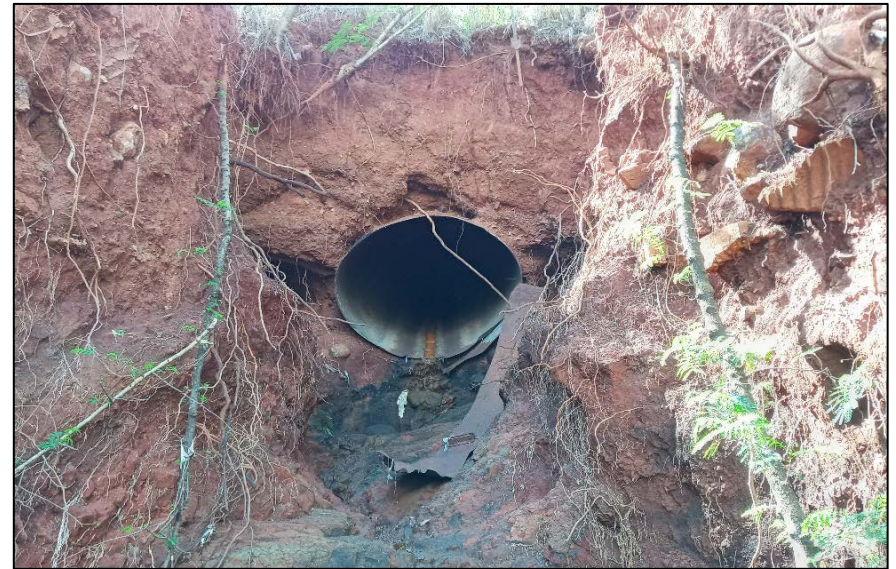
**Erosion at outfall**

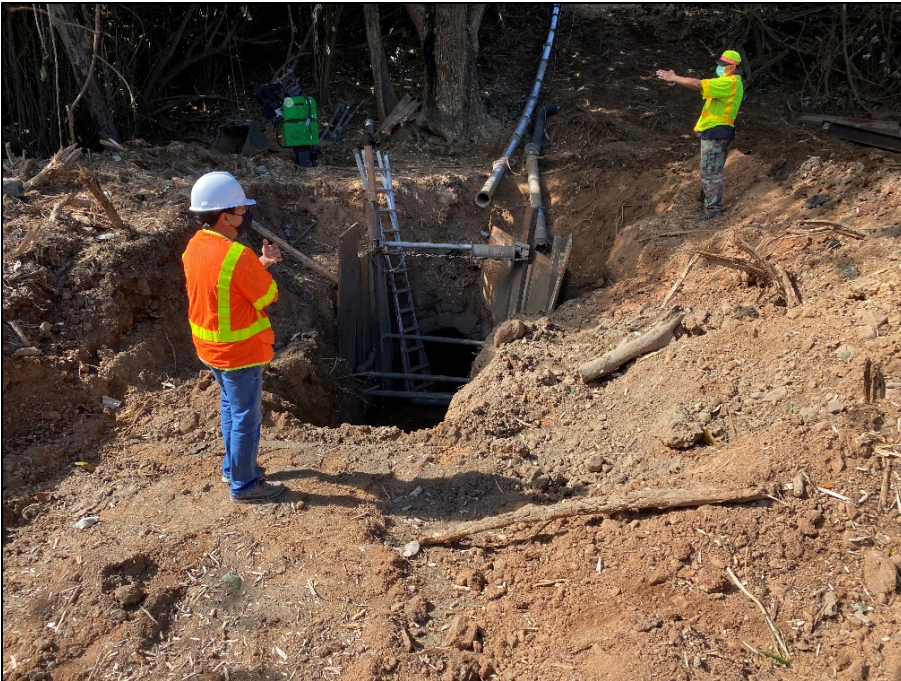
**Outfall Description:** PID 304664 is an outfall that drains a network of open channels that collect storm water from the H-3 Freeway near Kaneohe. The area immediately downstream of the headwall is currently supported by trench shoring to prevent sediment from collapsing and burying and blocking the outfall.

**Sedimentation at outfall**

Stabilize embankments. Elevate outlet to surrounding grade.

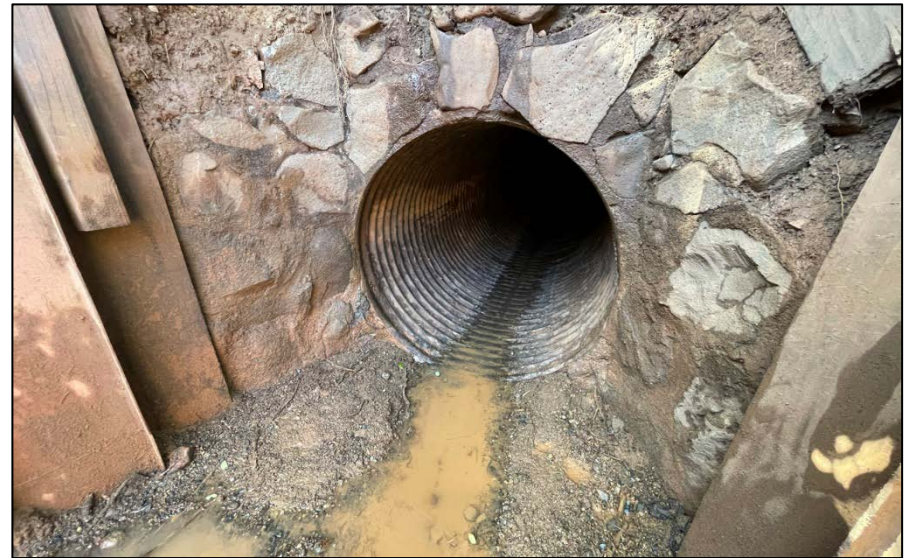
**Outfall after removing debris**

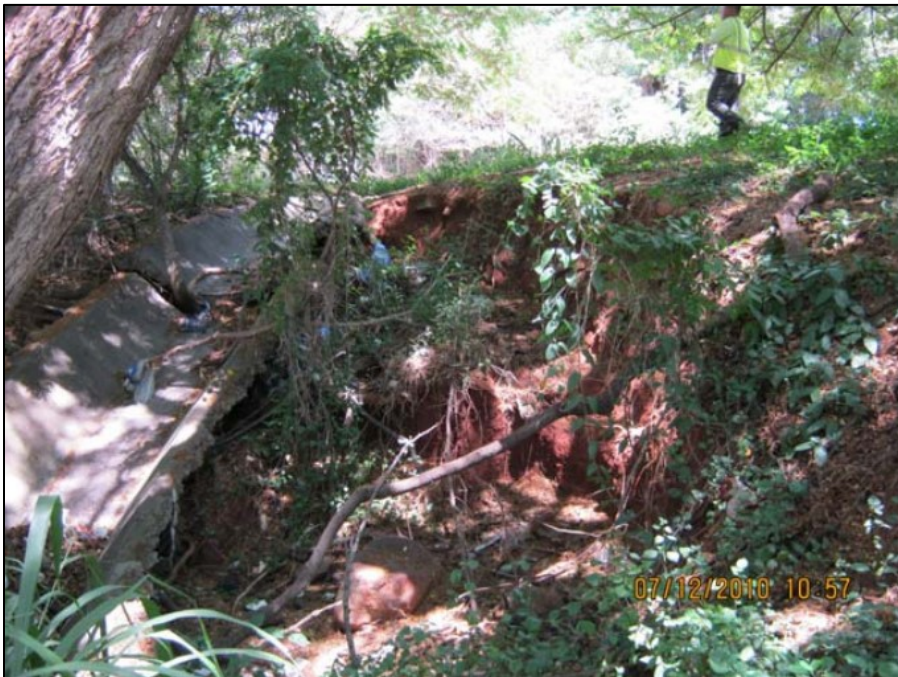
PID 301782 is a concrete open channel outfall that receives storm water runoff from catch basins and open channels located along the H-1 Freeway near Moanalua Road. The concrete channel is breaking apart in several locations and there is significant erosion at the outfall with sedimentation downstream of the outfall.

**Erosion at outfall**

Repair eroded areas and replace concrete channel and outfall.

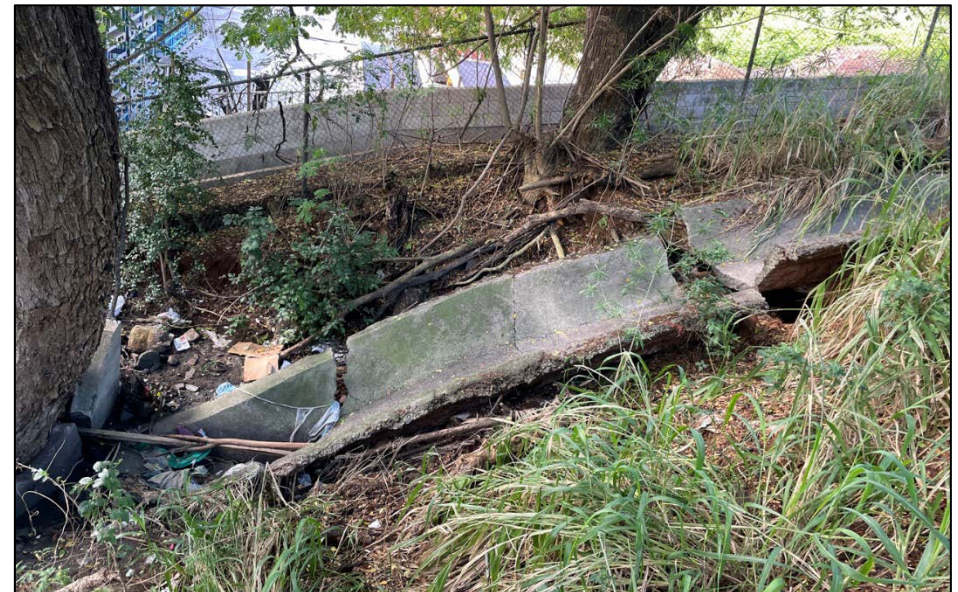
**Failing concrete liner at outfall**
