Action Plan to Address Erosional Outfalls

State of Hawaii, Department of Transportation
Highways Division, Oahu District
SWMPP, February 2022

STATE OF HAWAII, DEPARTMENT OF TRANSPORTATION
HIGHWAYS DIVISION, OAHU DISTRICT

STORM WATER MANAGEMENT PROGRAM ACTION PLAN TO ADDRESS EROSIONAL OUTFALLS

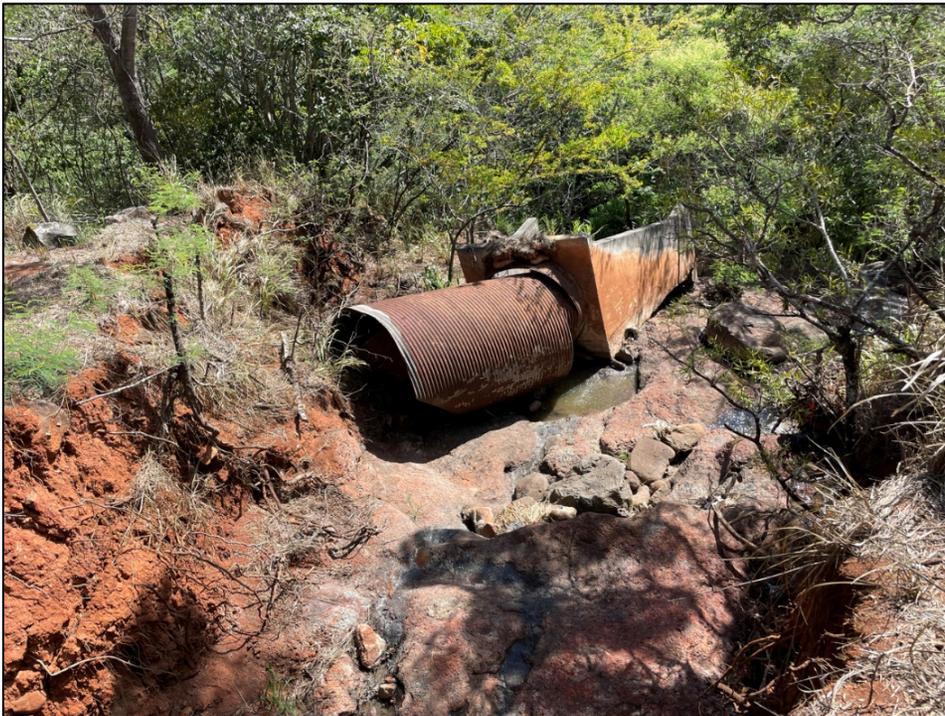
Outfall Description: PID 300732 is an outfall that drains a network of several catch basins that collect storm water from a residential neighborhood across the H-2 Freeway in Waipio. Heavy flow has eroded the surrounding soil and undermined the outlet headwall structure to the extent that it has separated from the rest of the culvert.

Failed concrete outlet structure downstream of outfall

New concrete outlet structure and outfall stabilization.

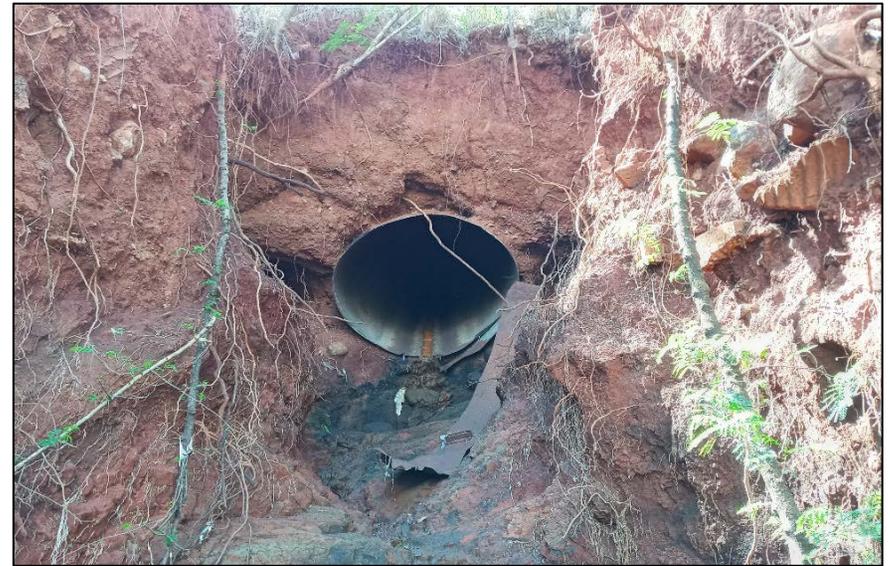
Erosion at outfall

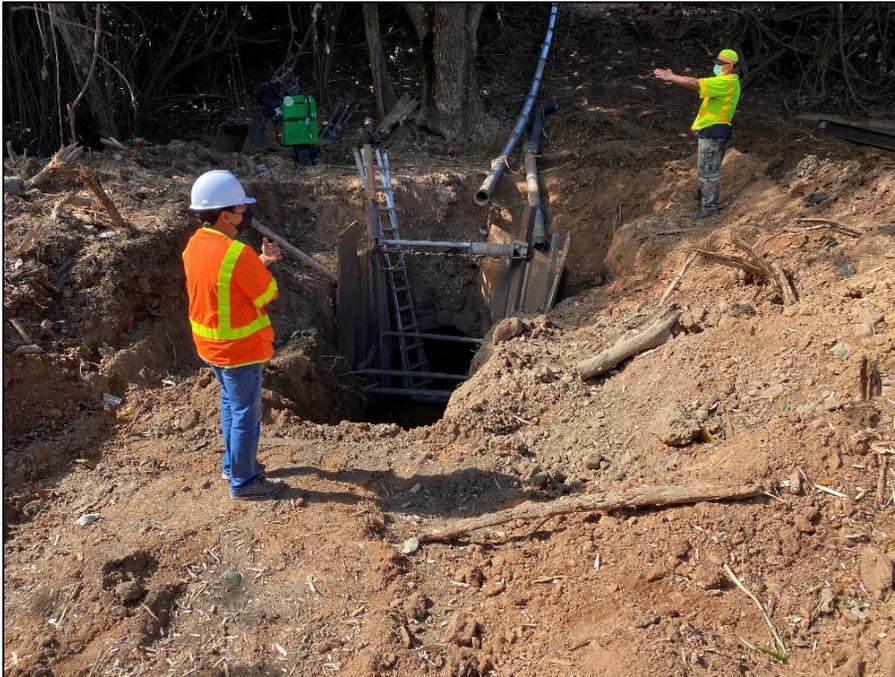
Outfall Description: PID 304664 is an outfall that drains a network of open channels that collect storm water from the H-3 Freeway near Kaneohe. The area immediately downstream of the headwall is currently supported by trench shoring to prevent sediment from collapsing and burying and blocking the outfall.

Sedimentation at outfall

Stabilize embankments. Elevate outlet to surrounding grade.

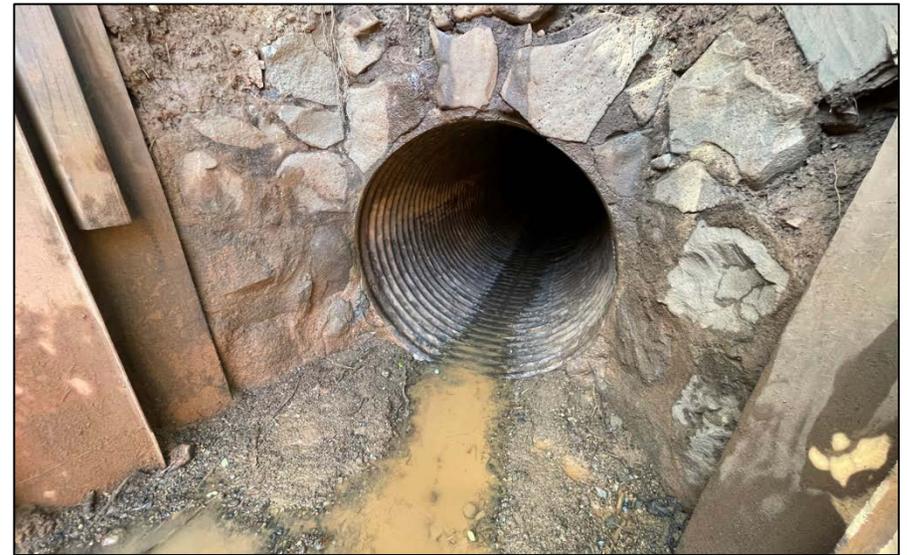
Outfall after removing debris

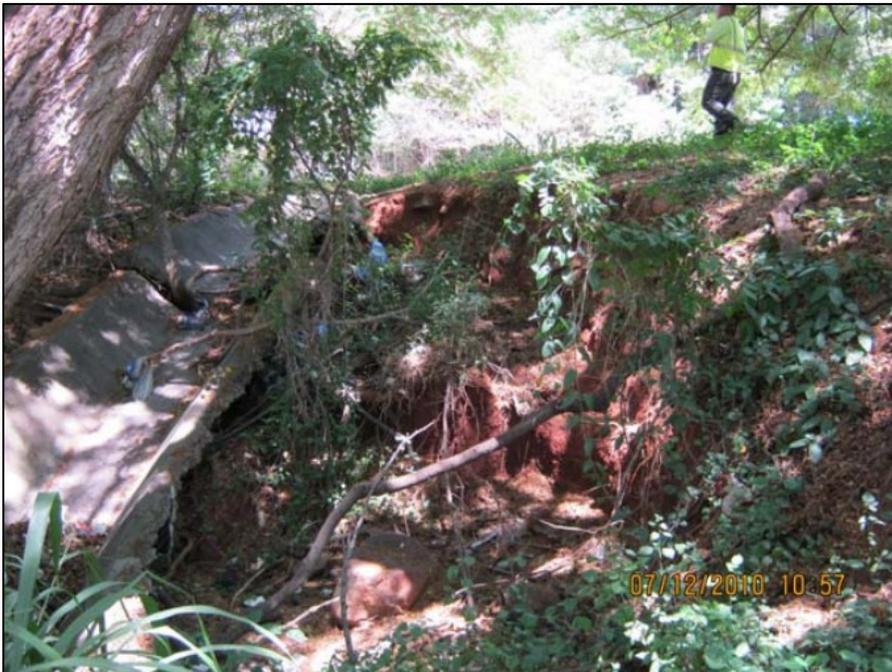
PID 301782 is a concrete open channel outfall that receives storm water runoff from catch basins and open channels located along the H-1 Freeway near Moanalua Road. The concrete channel is breaking apart in several locations and there is significant erosion at the outfall with sedimentation downstream of the outfall.

Erosion at outfall

Repair eroded areas and replace concrete channel and outfall.

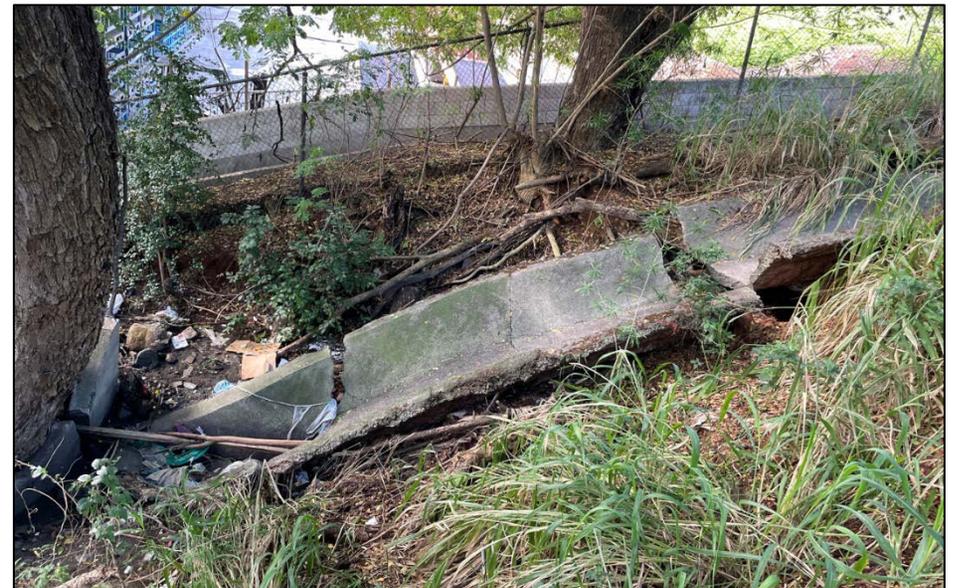
Failing concrete liner at outfall
