# Action Plan to Address Erosional Outfalls

State of Hawaii, Department of Transportation  
Highways Division, Oahu District  
SWMPP, February 2022

# STORM WATER MANAGEMENT PROGRAM ACTION PLAN TO ADDRESS EROSIONAL OUTFALLS

MS4 NPDES Permit No. HI S000001

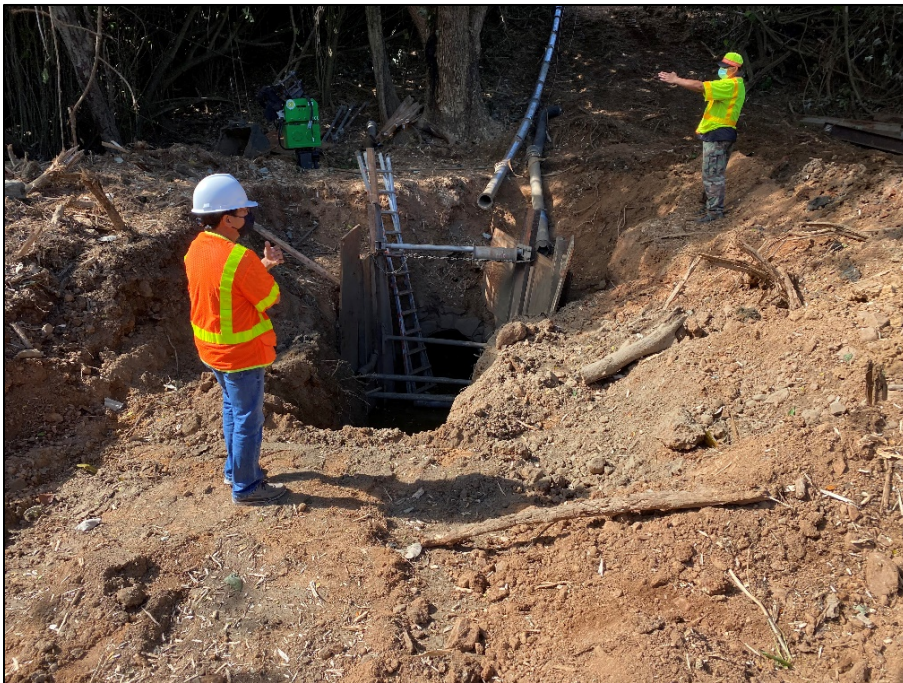
**Outfall Description:** PID 304664 is an outfall that drains a network of open channels that collect storm water from the H-3 Freeway near Kaneohe. The area immediately downstream of the headwall is currently supported by trench shoring to prevent sediment from collapsing and burying and blocking the outfall.

**Sedimentation at outfall**

Stabilize embankments. Elevate outlet to surrounding grade.

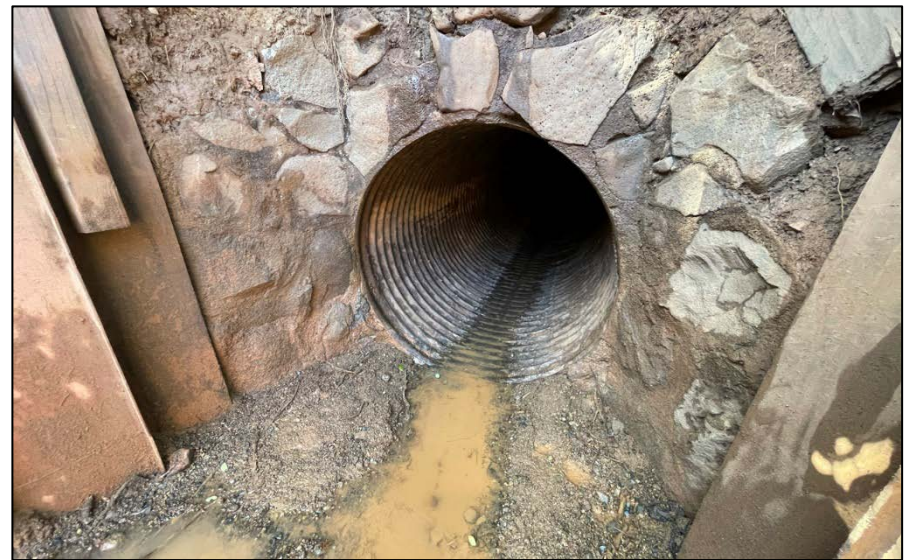
**Outfall after removing debris**
