The Replacement of Makaha Bridges 3 and 3A

Ben Garde, P.E. and Chord Medeiros

Makaha Bridges 3 and 3A

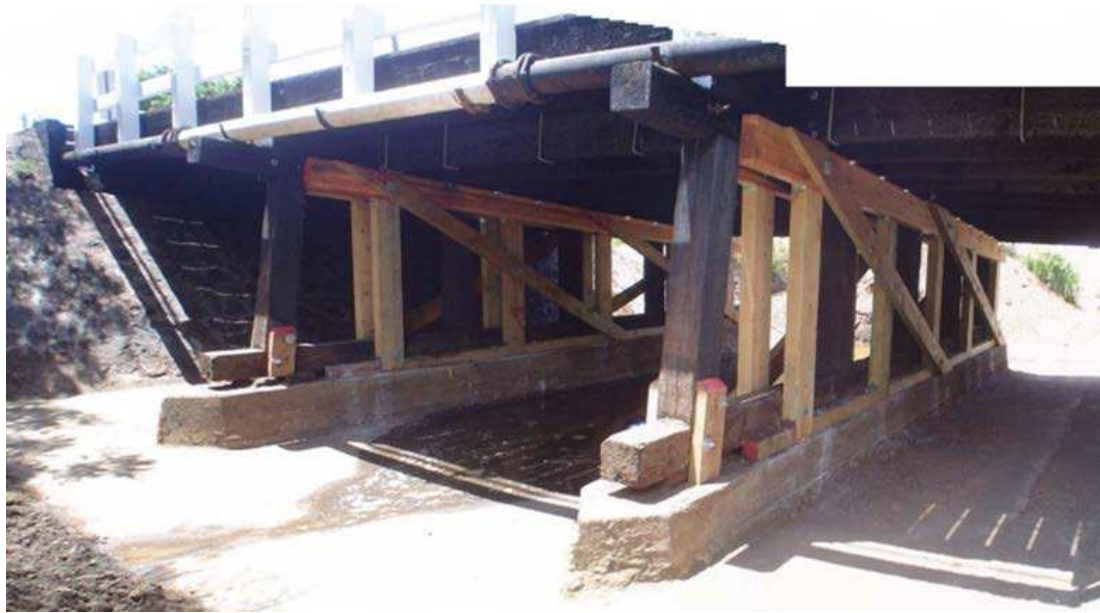
Existing Bridge 3

Existing Bridges 3 and 3A Descriptions

SPANS –

Bridge 3 – Three

SUPERSTRUCTURE –

Wood Plank Deck on Wood Beams

SUBSTRUCTURE –

Abutments - Concrete

Piers – Wood Caps and Columns

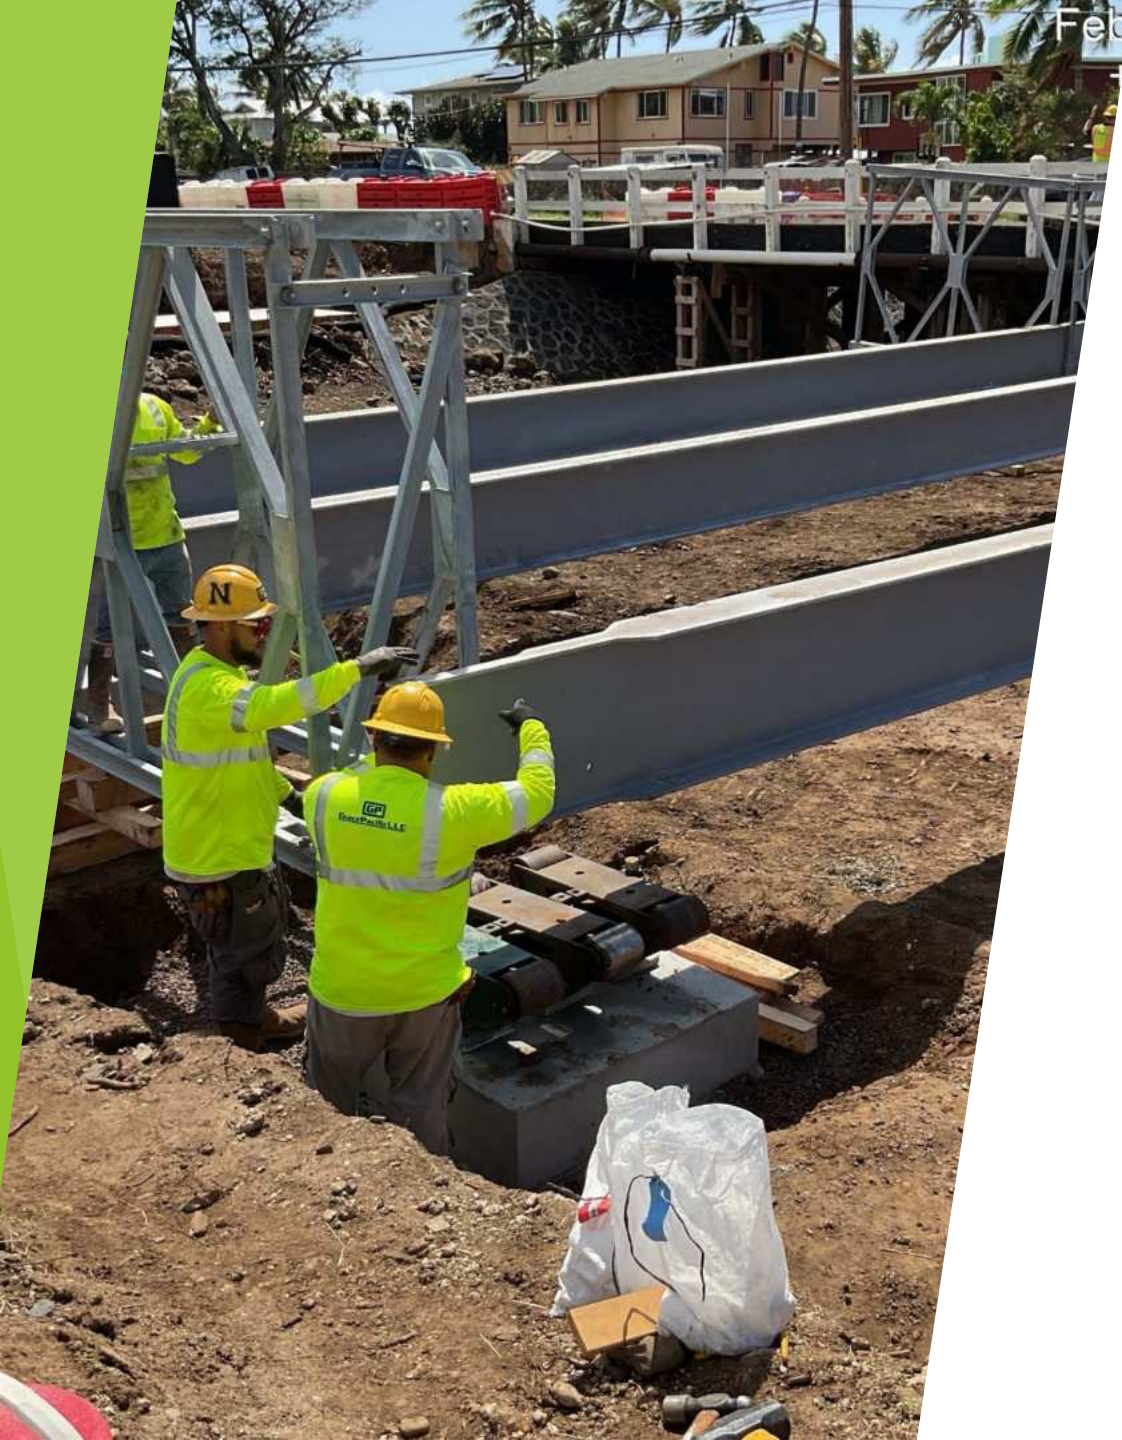
Design of New Bridges

- ▶ Single Span Prefabricated Steel Trusses
- ▶ Bridge Improvements
 - ▶ Designed for Current Live Loads
 - ▶ Adequate Hydraulic Opening
 - ▶ Provide Shoulders

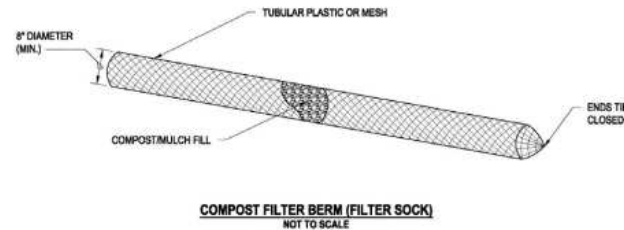
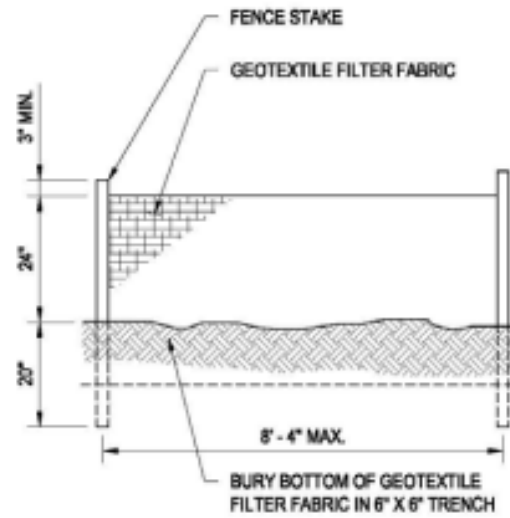
Compost Filter Berm/Sock

- ▶ Compost Filter Sock (SC-6)
 - ▶ Reduce Flow Velocity
 - ▶ Retains Sediment and Other Pollutants
- ▶ Silt Fence (SC-7)
 - ▶ Permeable Fabric
 - ▶ Intercept and Slow Storm Water That Has Sediment
- ▶ Challenge to Maintain in a Popular/ Frequented Area
 - ▶ Often Run Over or Ripped

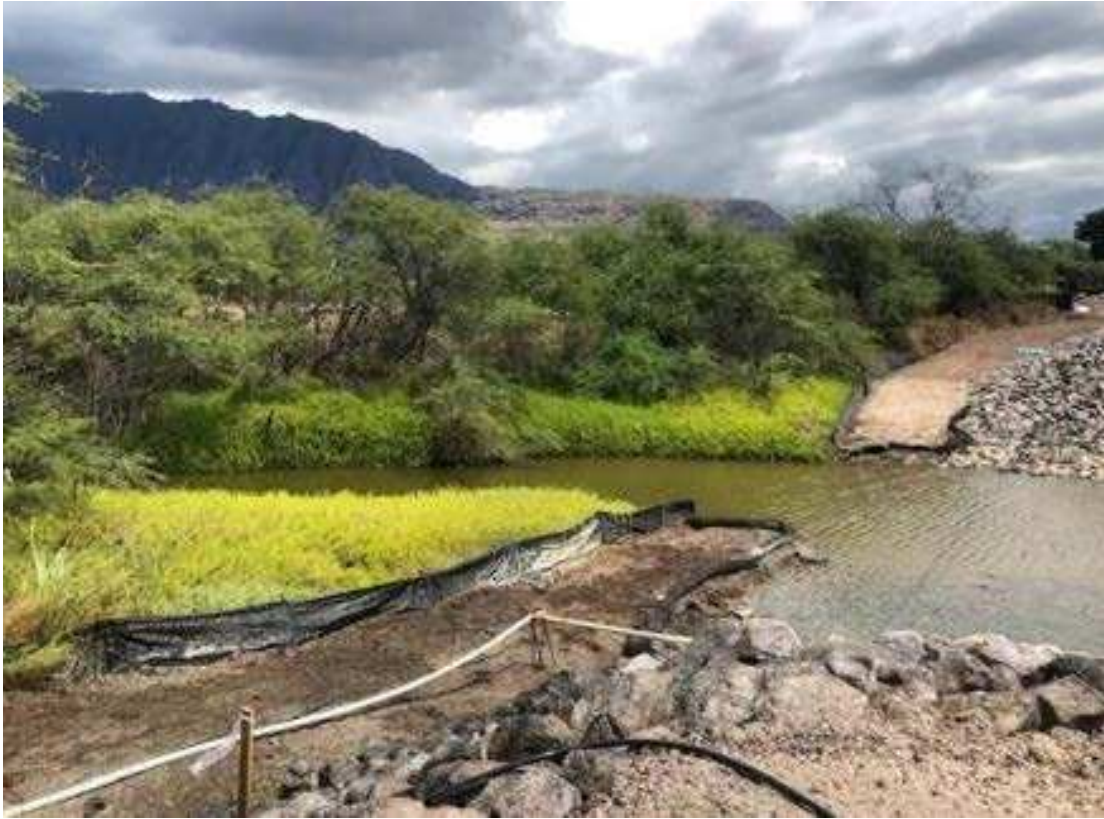
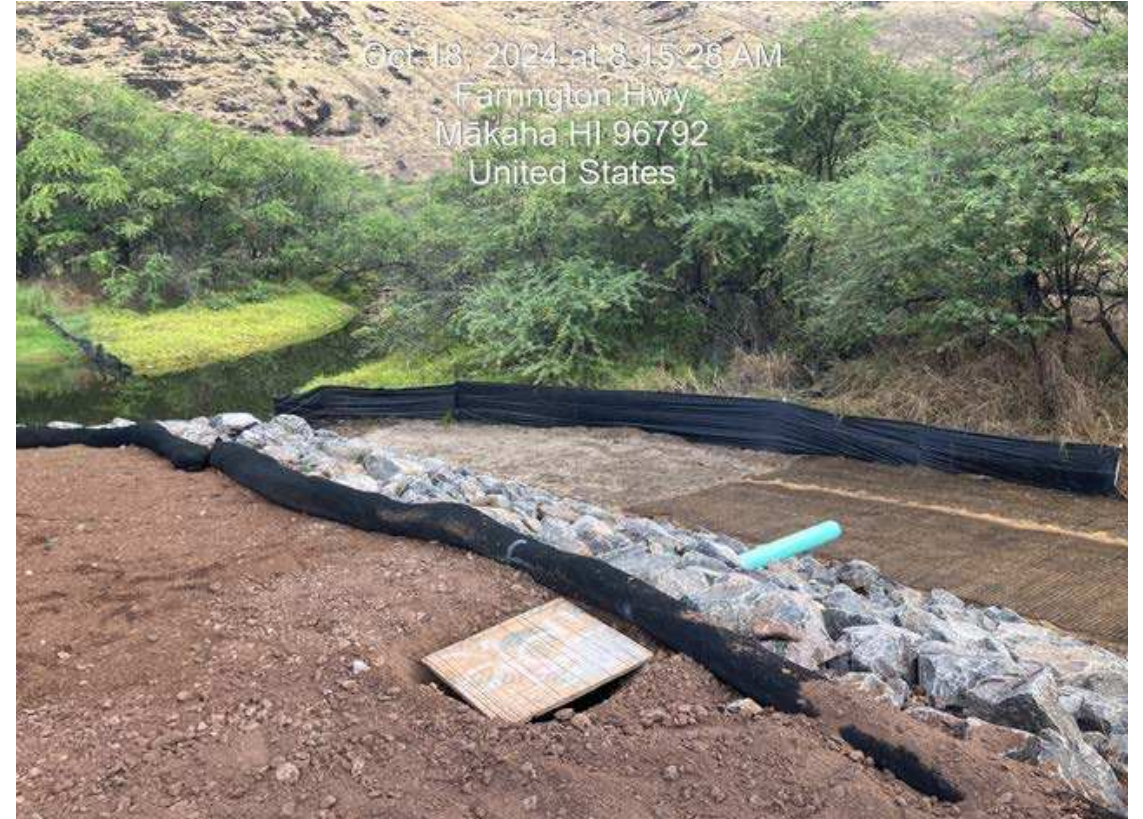
SC-6

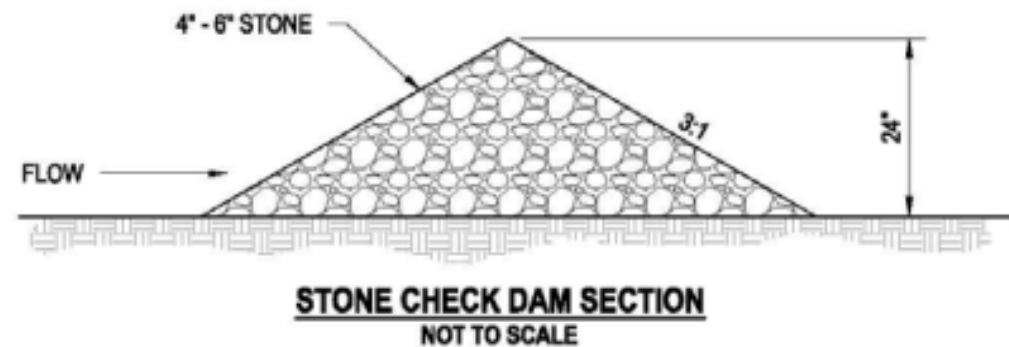
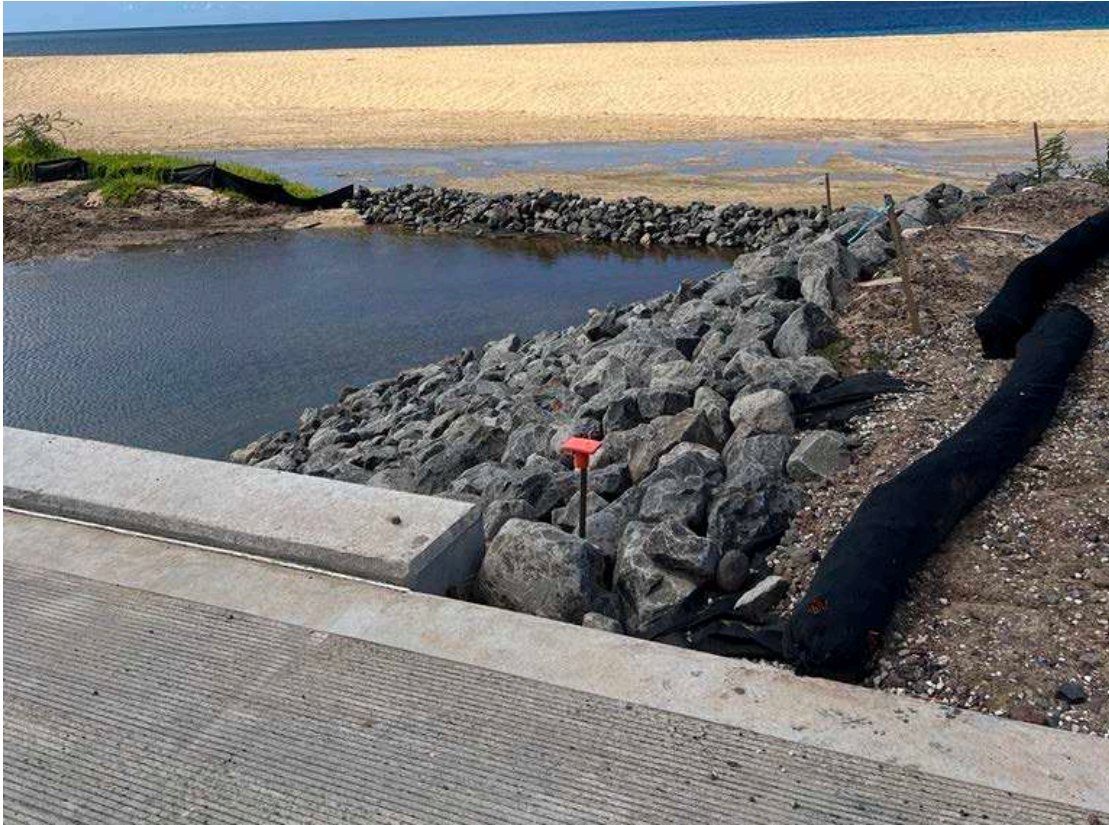
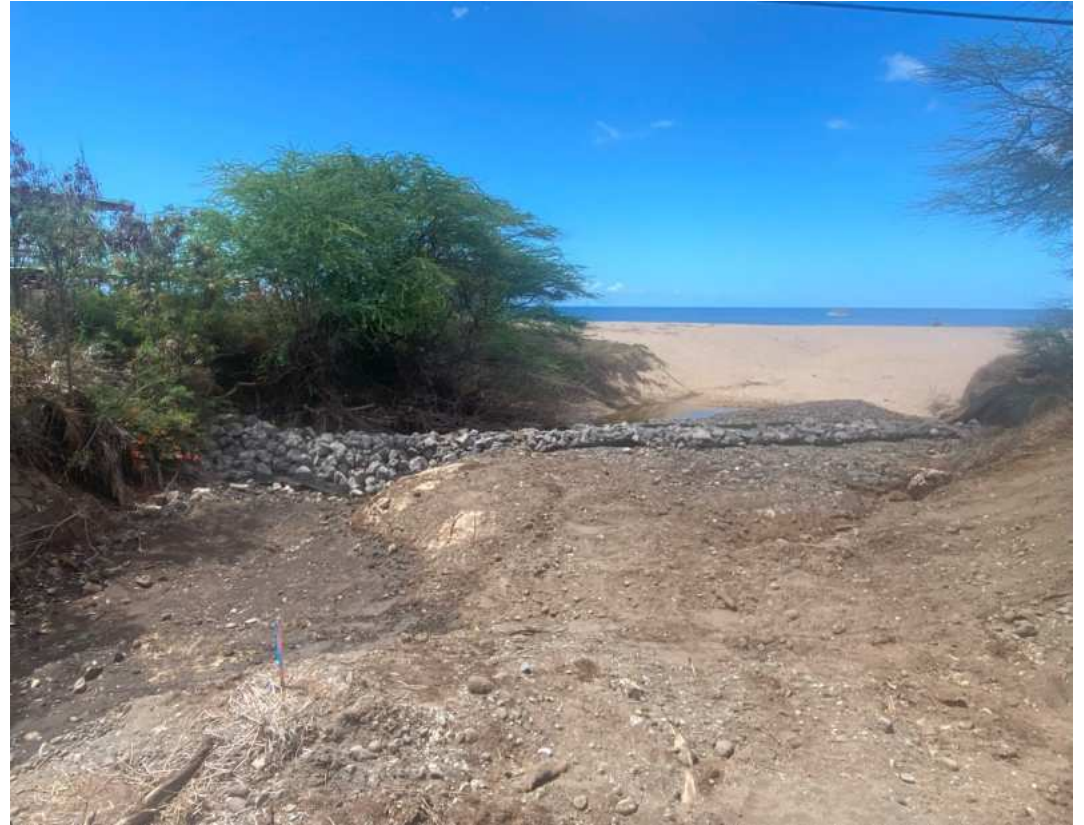
Check Dams (SC-3)

- ▶ Two Designated Locations
 - ▶ Makaha Stream (Br. 3)
 - ▶ West Makaha Stream (Br. 3A)
- ▶ Reduce Erosion
- ▶ Slows Velocity of Water
- ▶ Catches Sediment

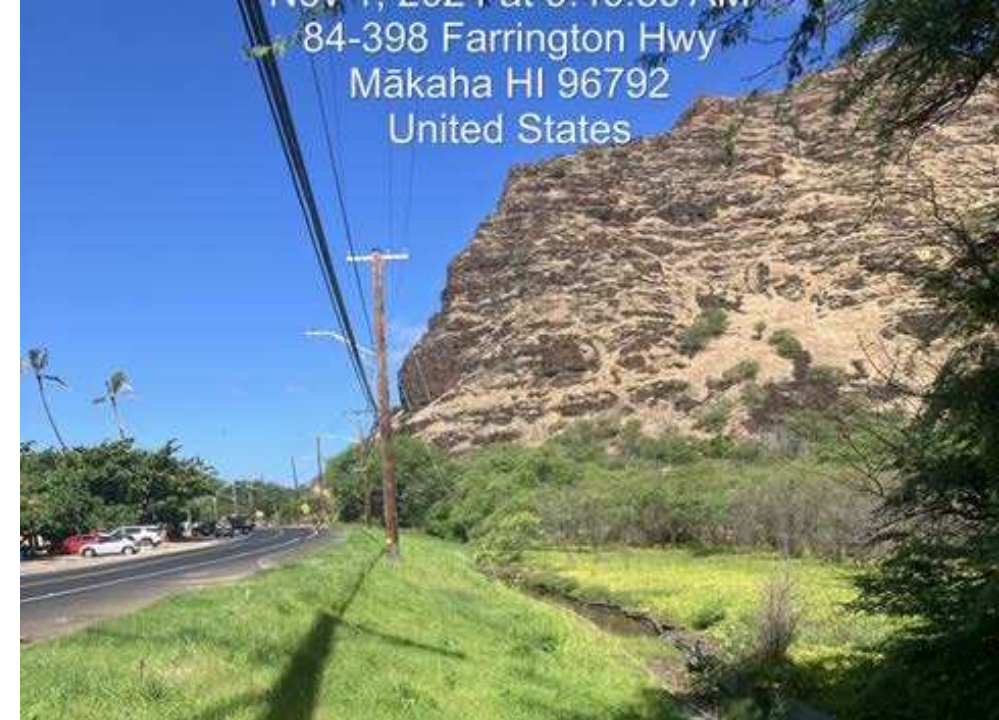
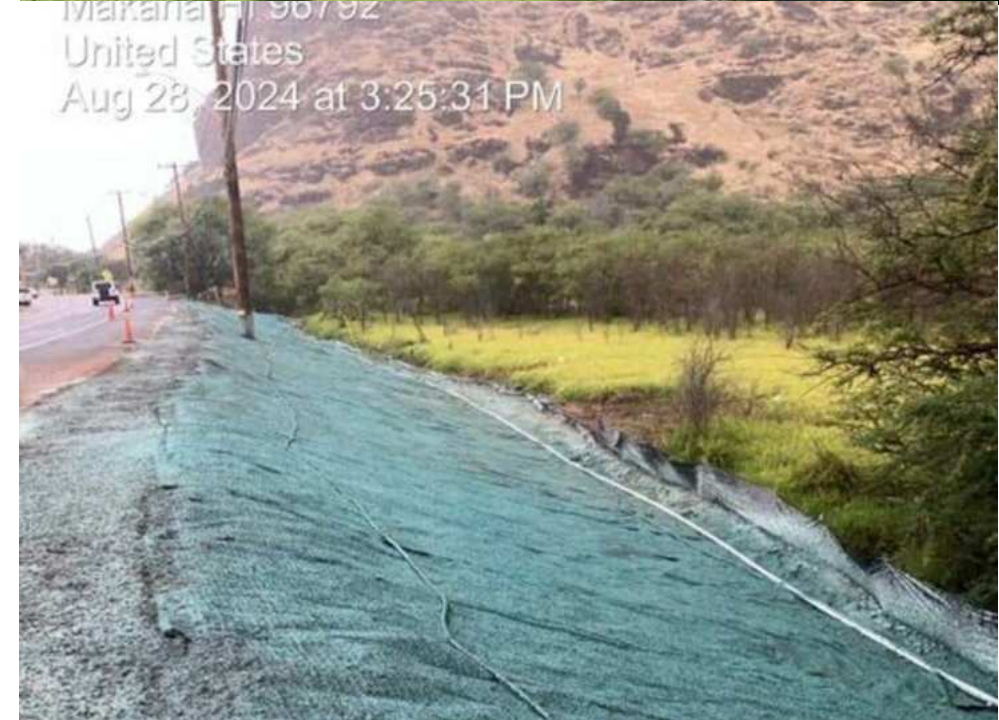
Hydro Seed and Mulch (EC-13, EC-15)

- ▶ Earthwork along new bridges and highway
 - ▶ Embankments
 - ▶ Exposed Soil
 - ▶ Dry Area
- ▶ Apply mixture of loose bulk material, seeds, fertilizer and more
 - ▶ Protects bare soil
 - ▶ Increasing Infiltration
 - ▶ Promotes vegetation
 - ▶ Irrigation
 - ▶ Reducing Runoff

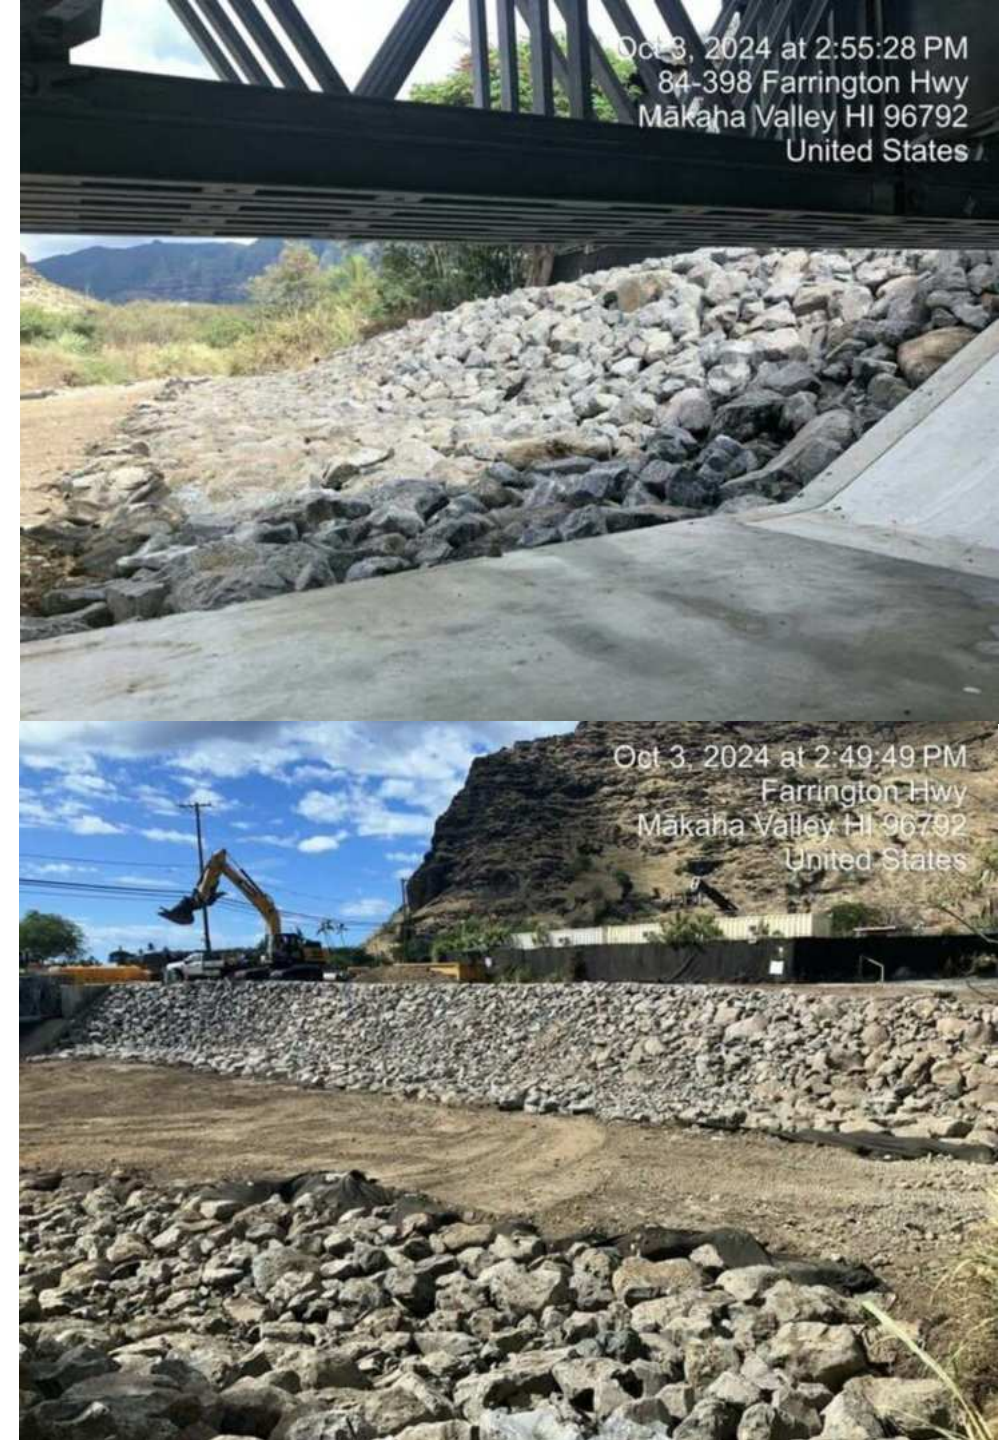
Riprap (EC-10)

- ▶ Permanent BMP
- ▶ Along Embankments
 - ▶ Makaha Stream (Br. 3)
 - ▶ West Makaha Stream (Br. 3A)
- ▶ Large, Irregular Size Rocks
 - ▶ Stabilizes Slopes
 - ▶ Protects Soil Surface
 - ▶ Slows Velocity of Runoff

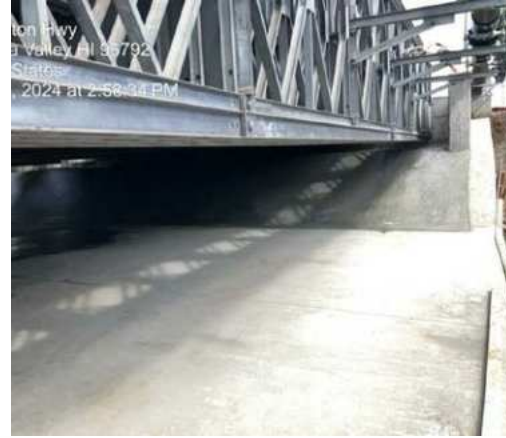
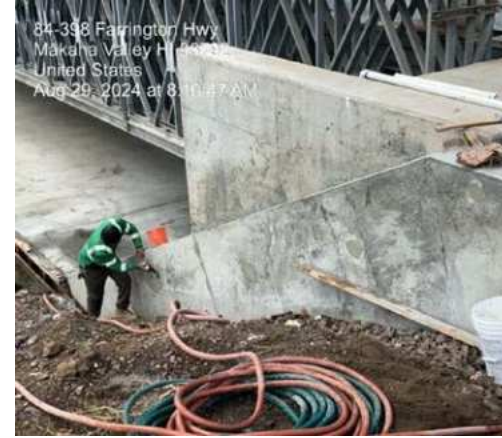
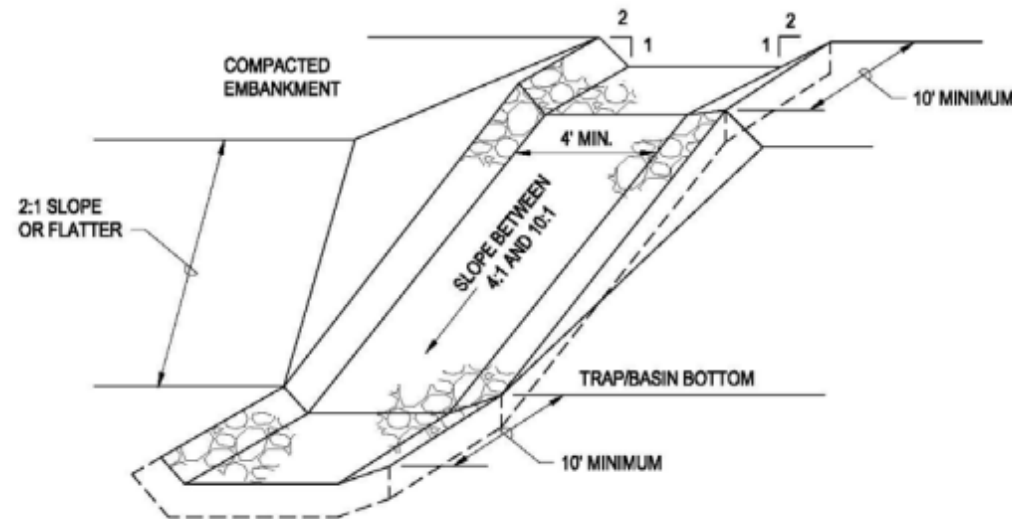
Channel Slab and Slope Wall

- ▶ Permanent BMP
- ▶ Under Bridge 3
 - ▶ Makaha Stream
- ▶ Concrete
 - ▶ Stabilizes Slopes
 - ▶ Protects Soil Surface
 - ▶ Erosion Protection

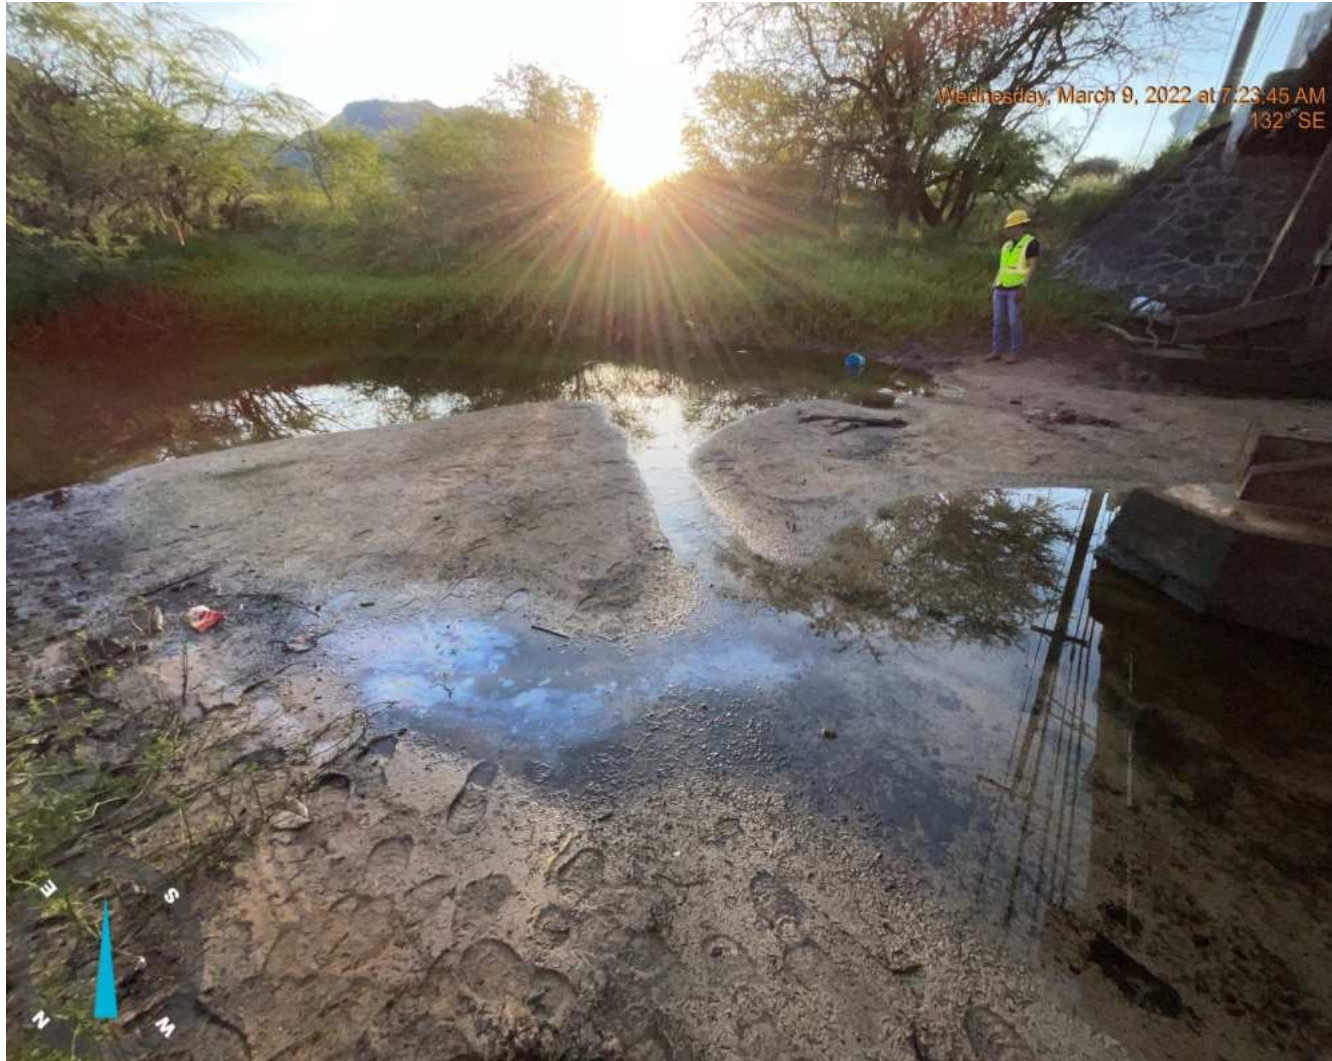
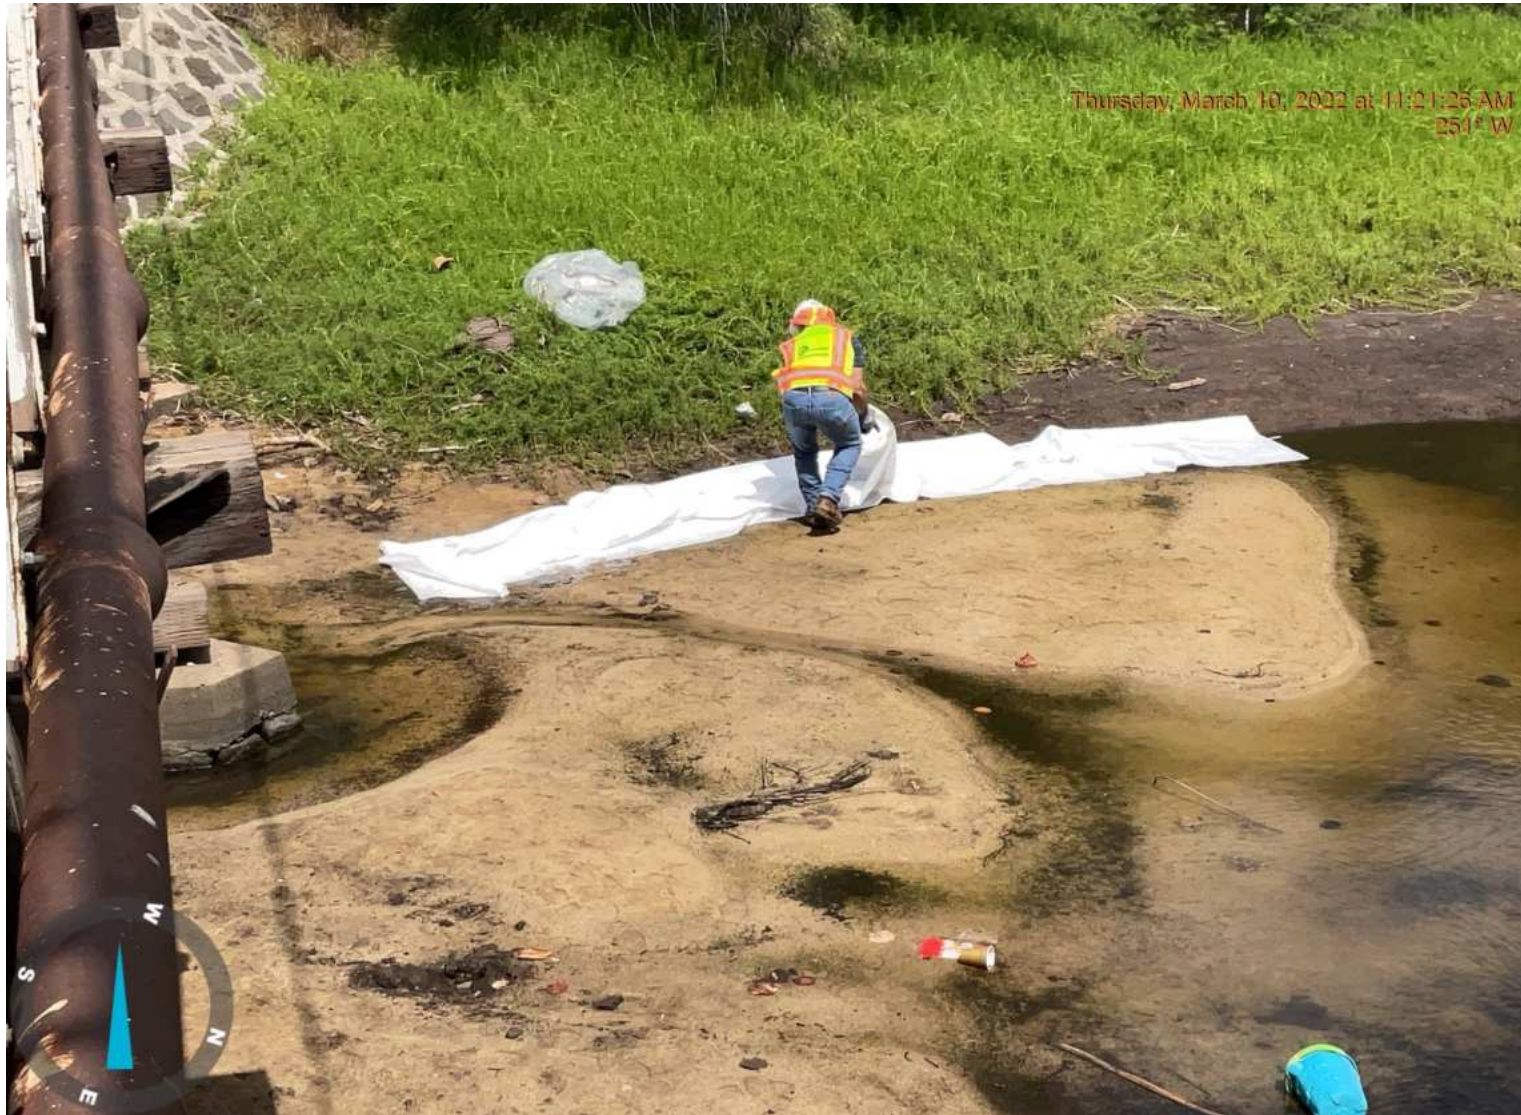
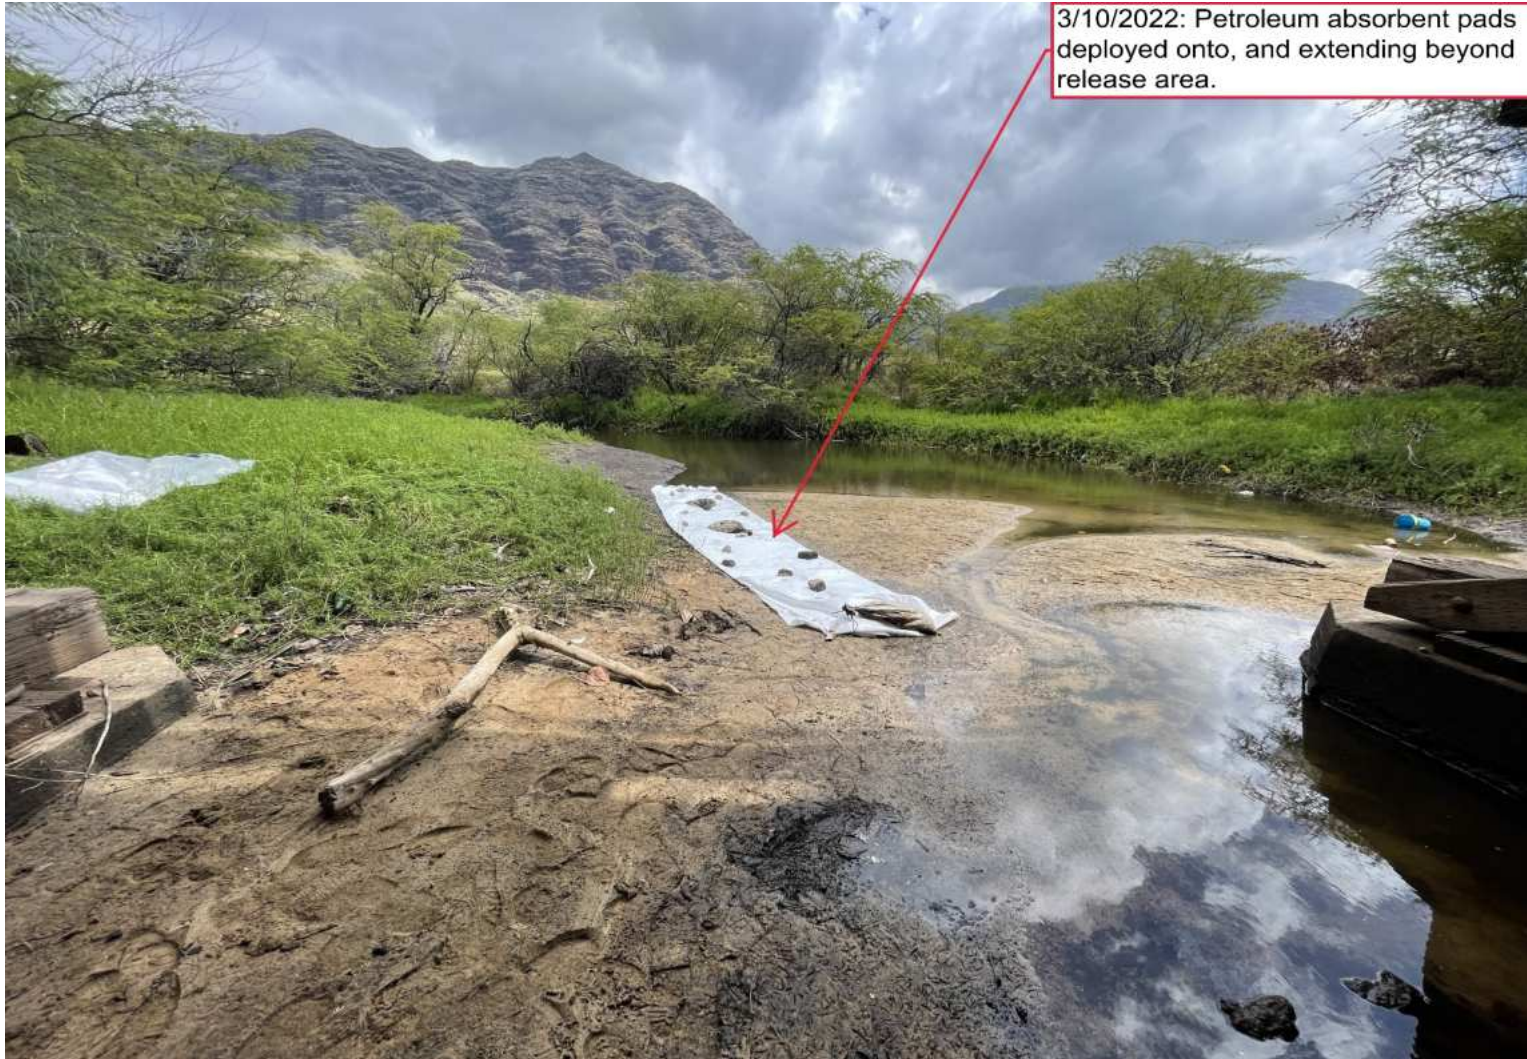
Hazardous Material

West Makaha Stream at Bridge 3A

Oily-Type Liquid Not Related to
Construction Work

Deploy Petroleum Sorbent Pads

3/10/2022: Petroleum absorbent pads deployed onto, and extending beyond release area.
