# Back On The Road: Emergency Highway Restoration After A Hurricane

# US 98 (Franklin County) Soft Armor Countermeasures Utilizing Polymer Technology (Case Study)

Josh Boan, FDOT EMO

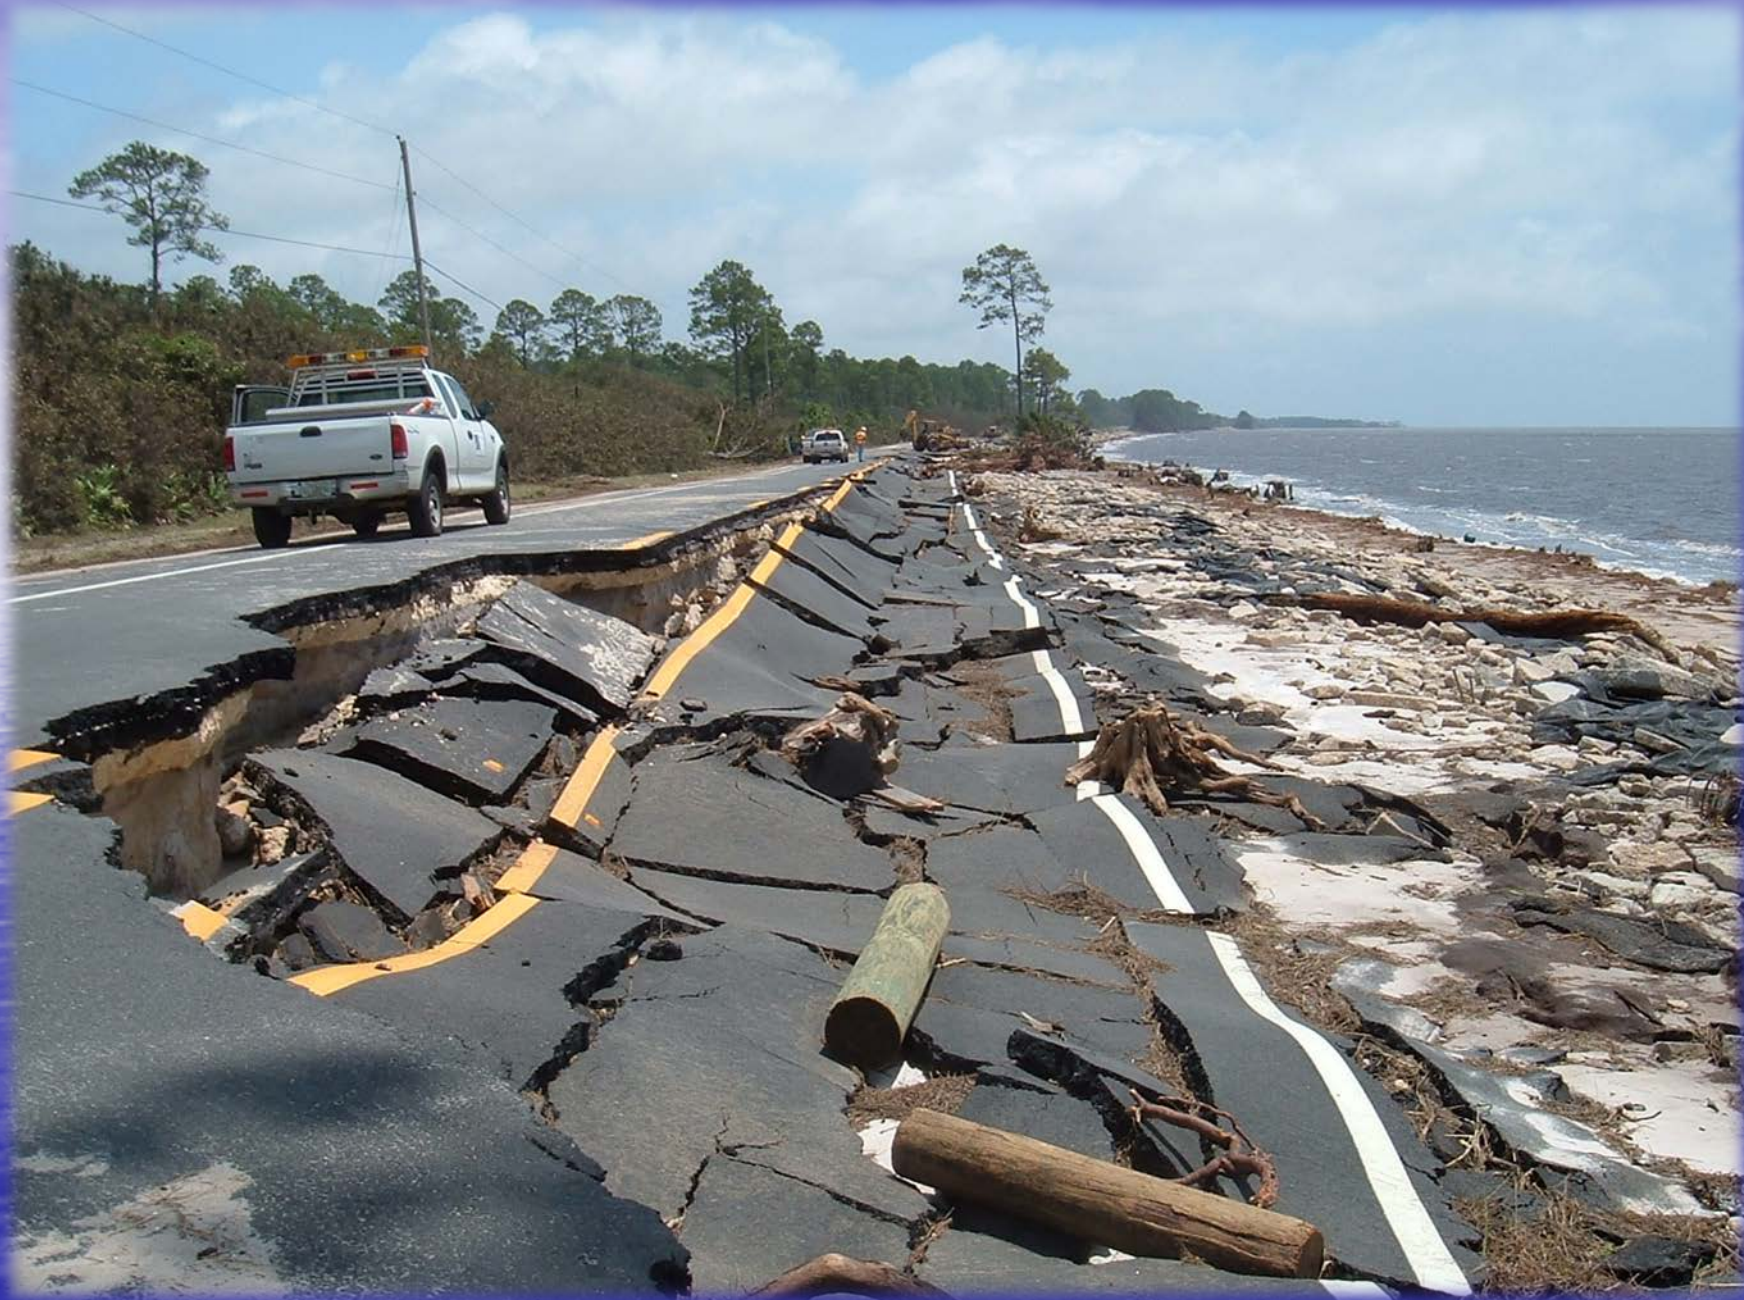
07/10/2005 1:03 pm

Severe impacts to coastal Highway 98

Damage from 6-8 feet storm surge + waves

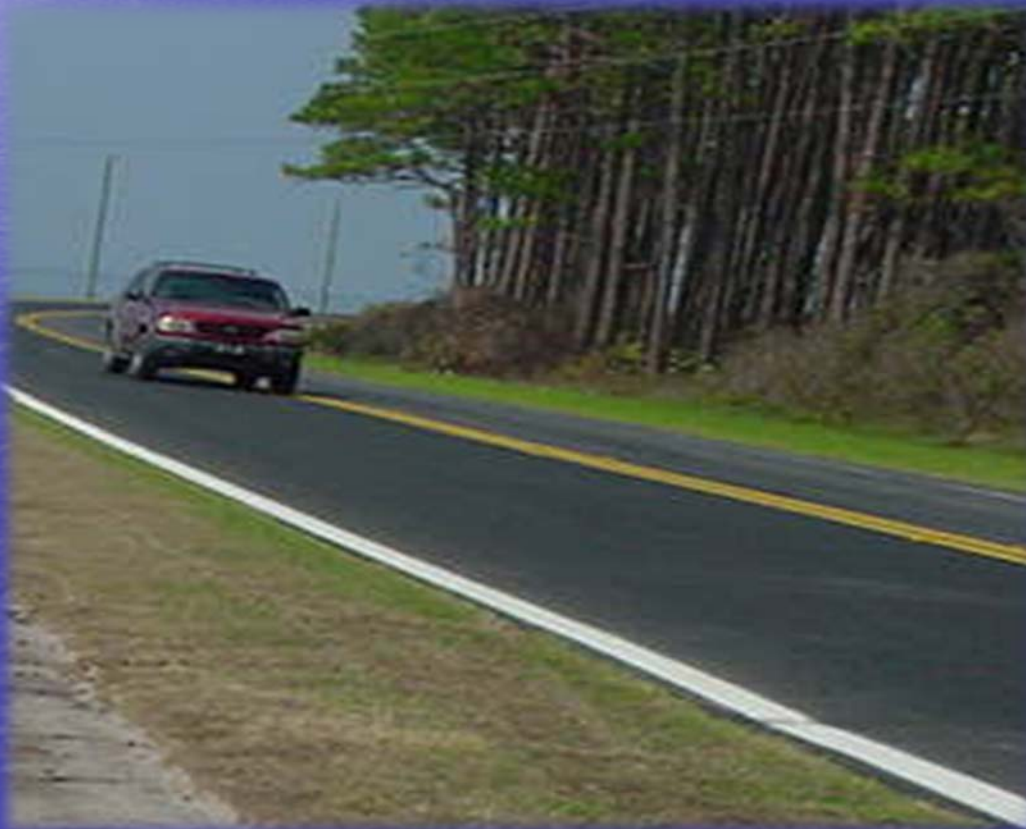
<One week later, problems!

Rainfall runoff causing erosion of  
coastal slope and shoulder

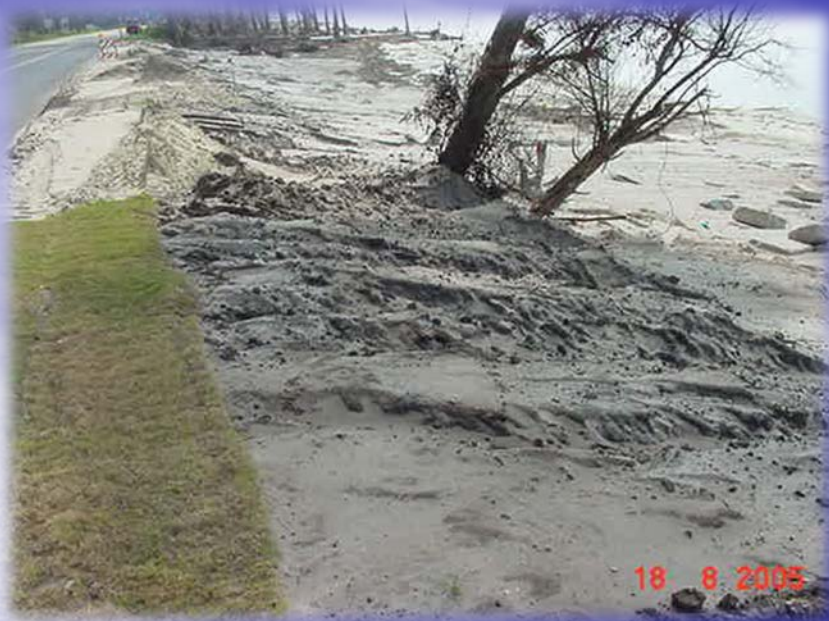
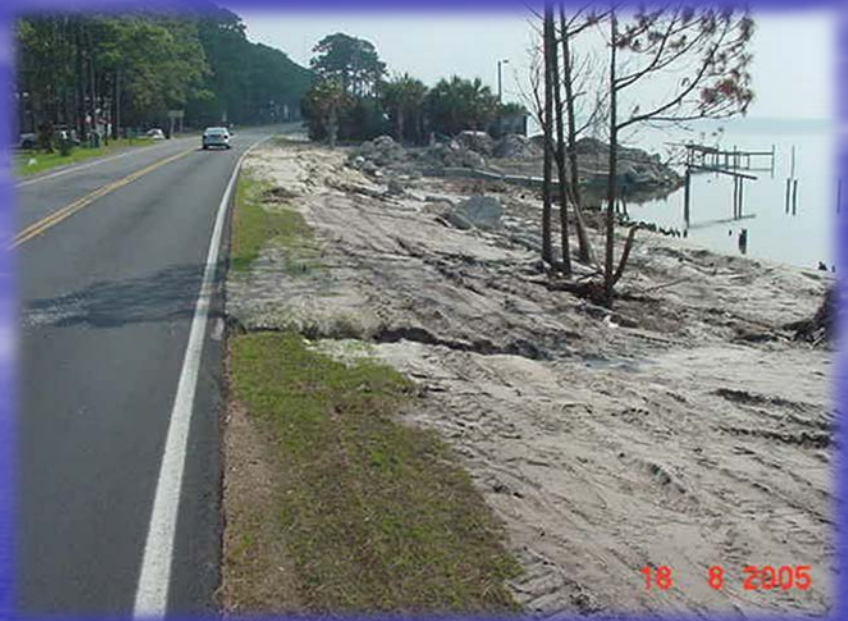
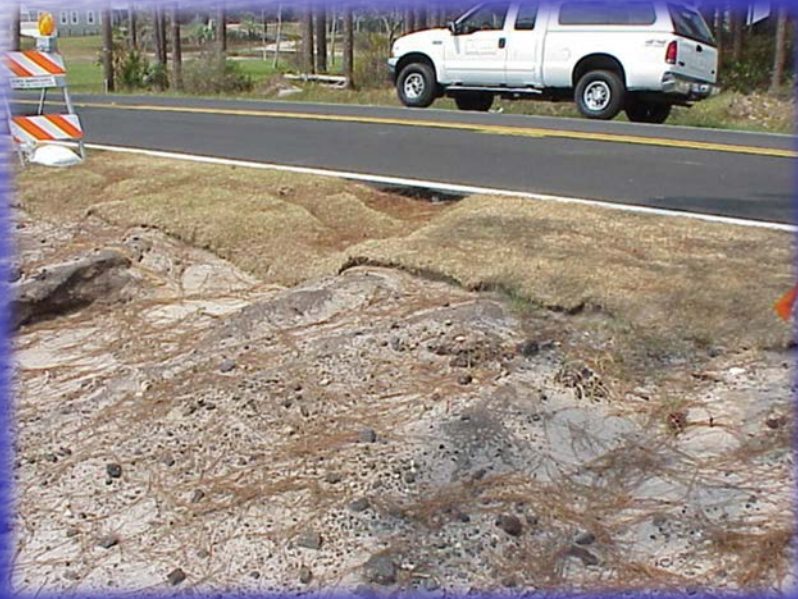
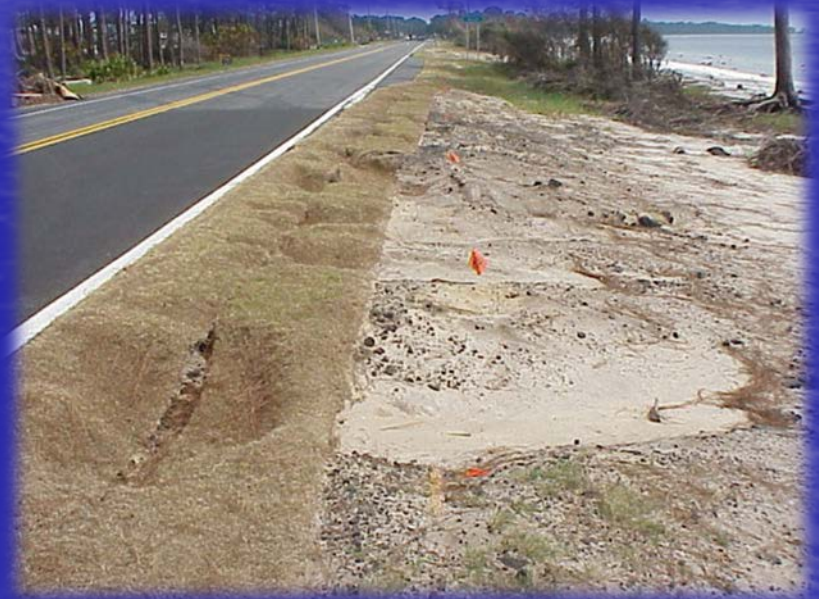
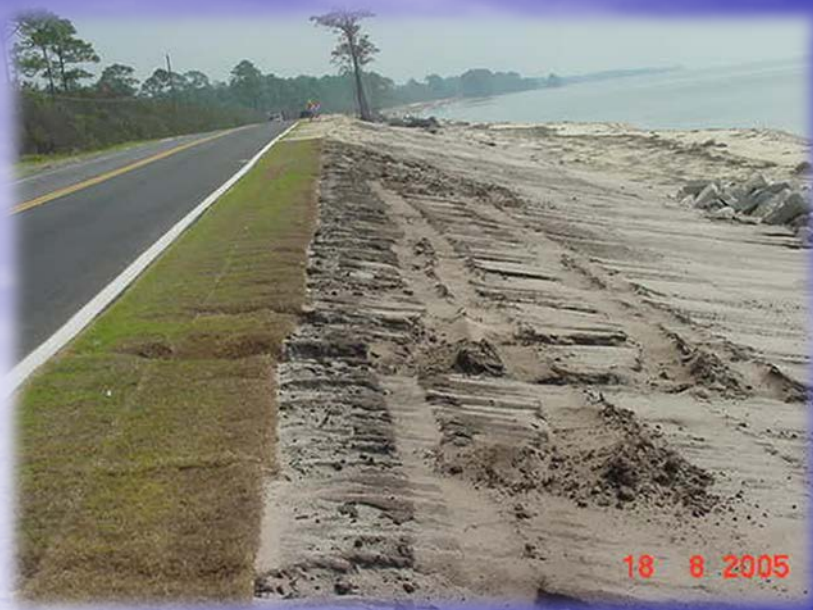
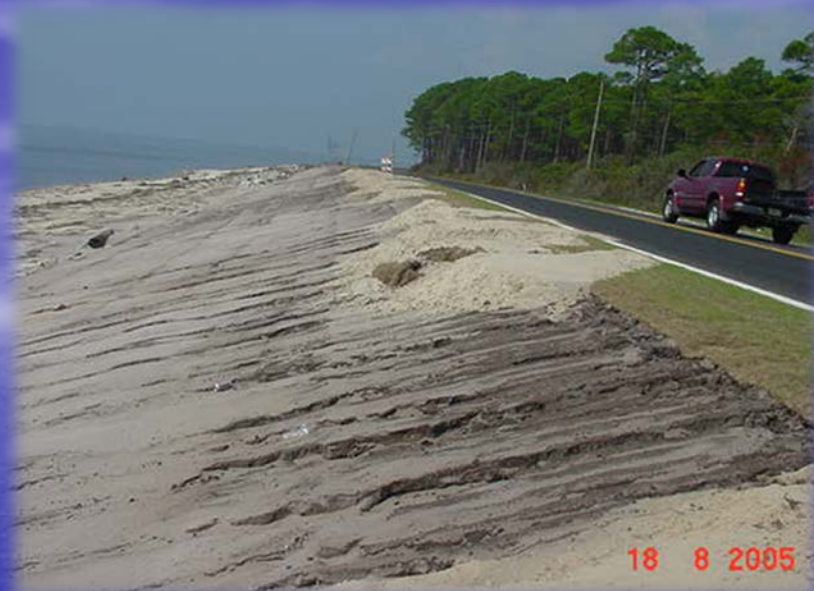
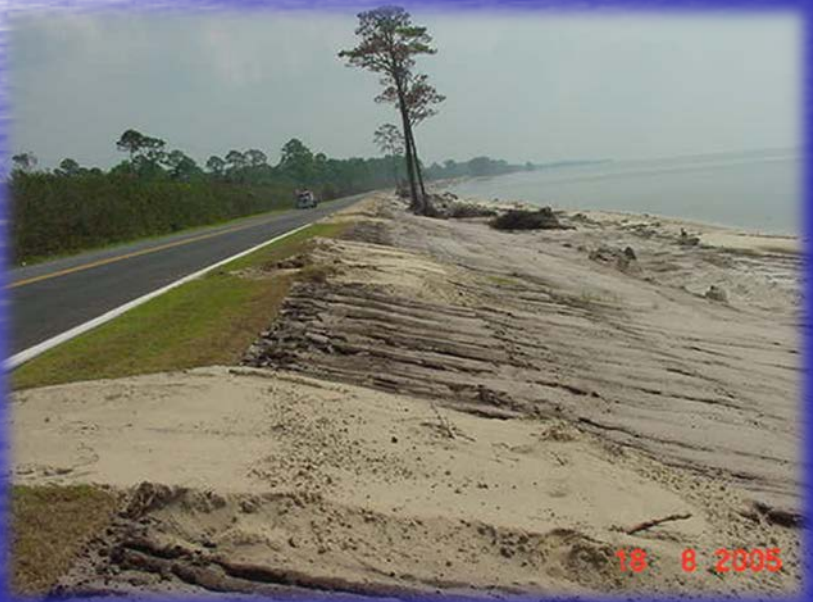
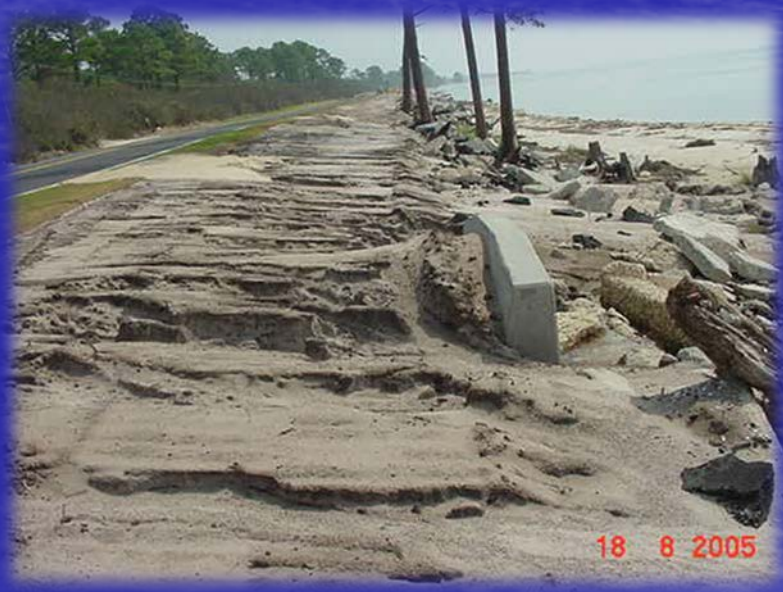
Fill material eroding beneath new sod

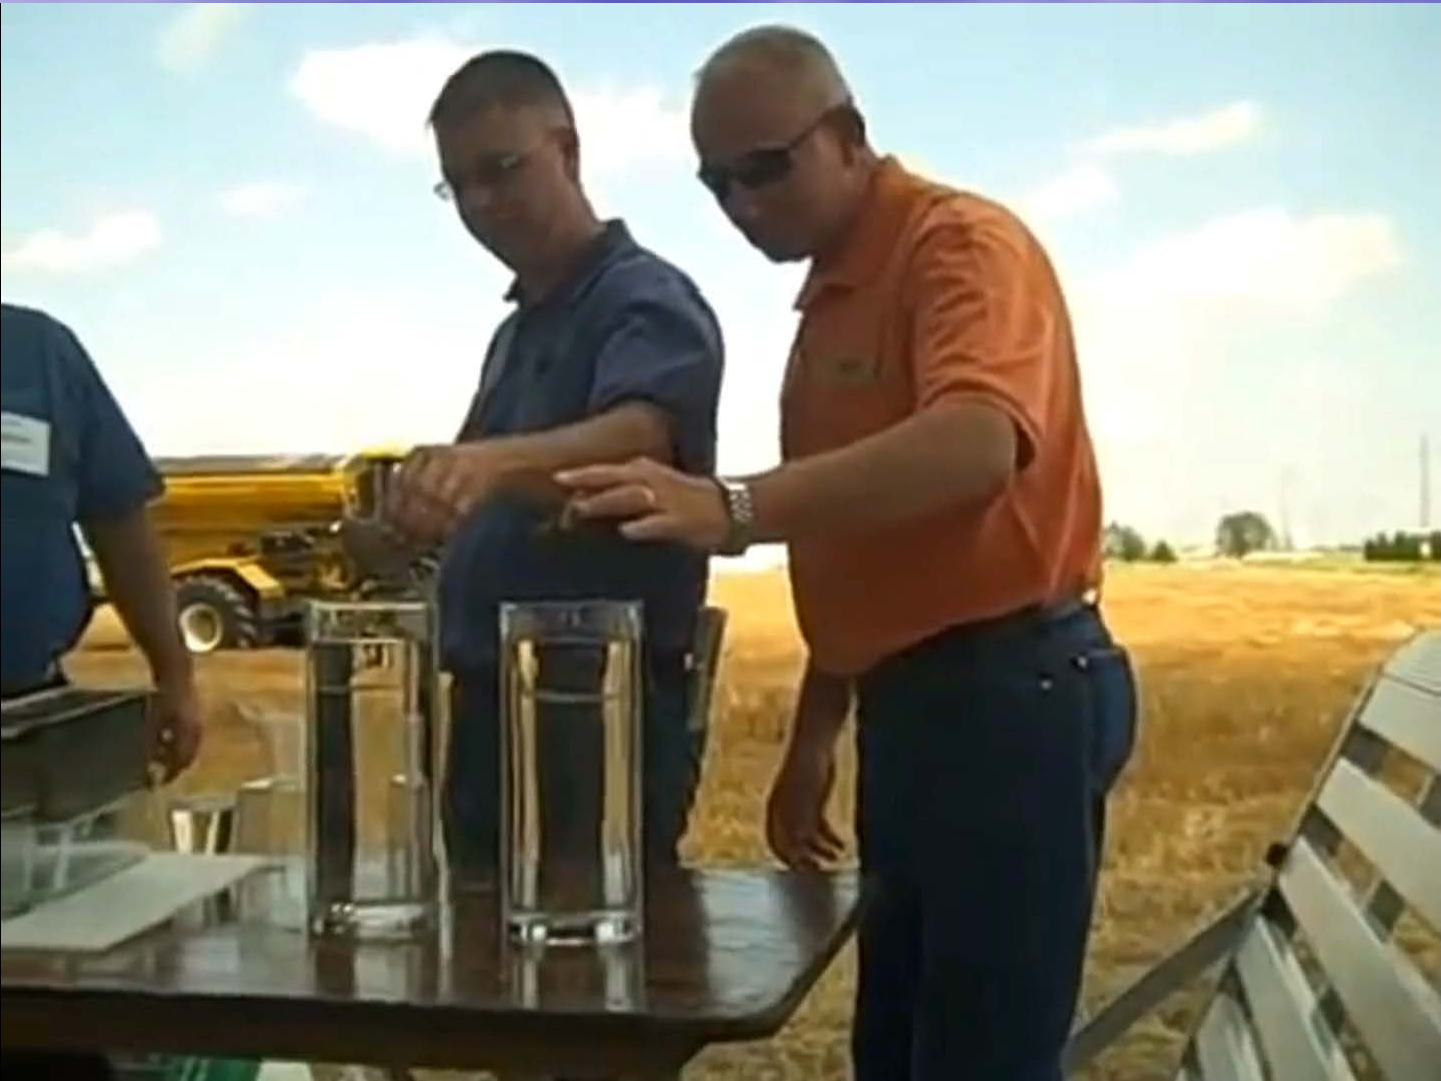
Poor soil  
structure

Sod installation on sand failed shortly after repair due to unstructured soil exposed to inundation. Sod roots failed to penetrate for stabilization of soil.

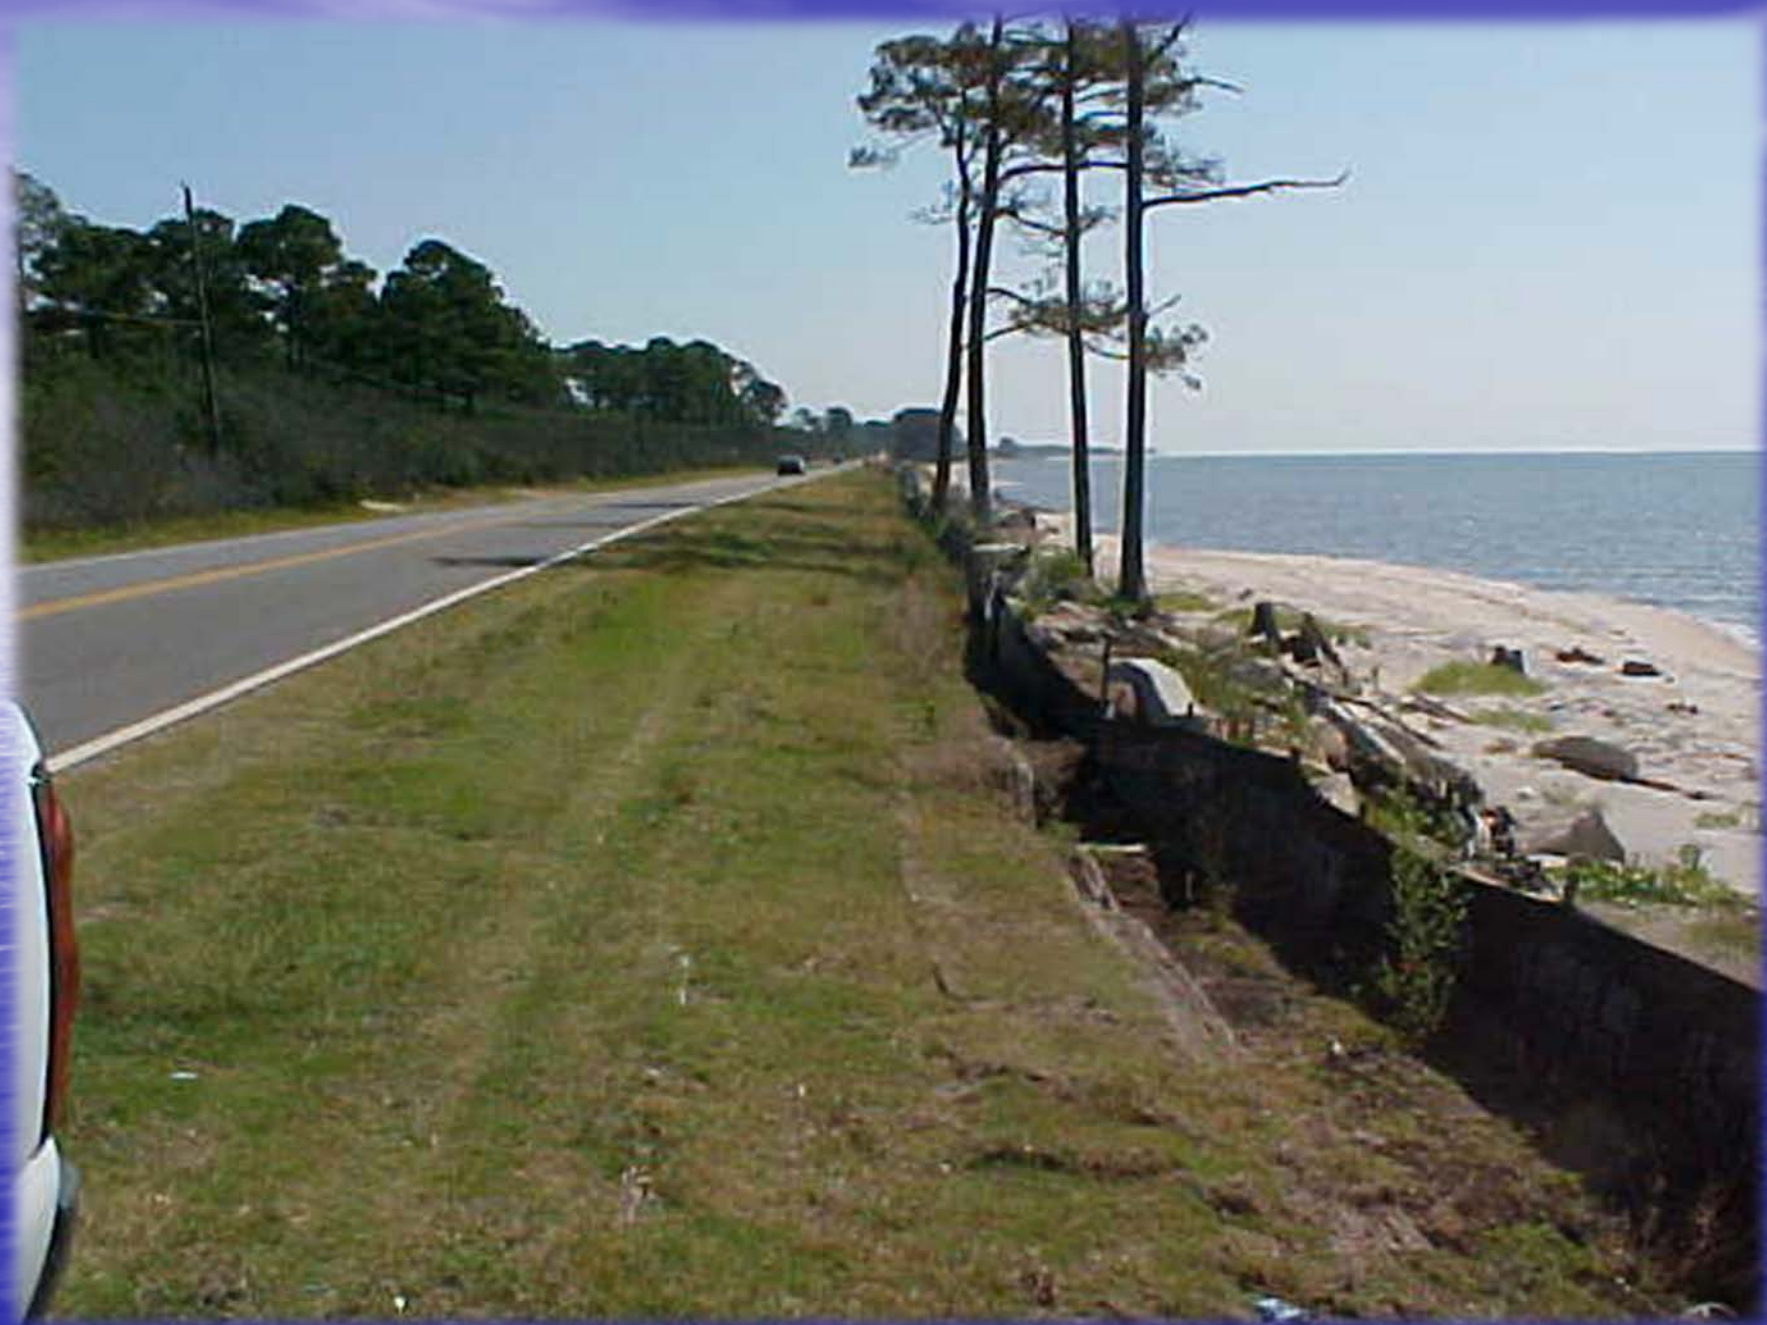
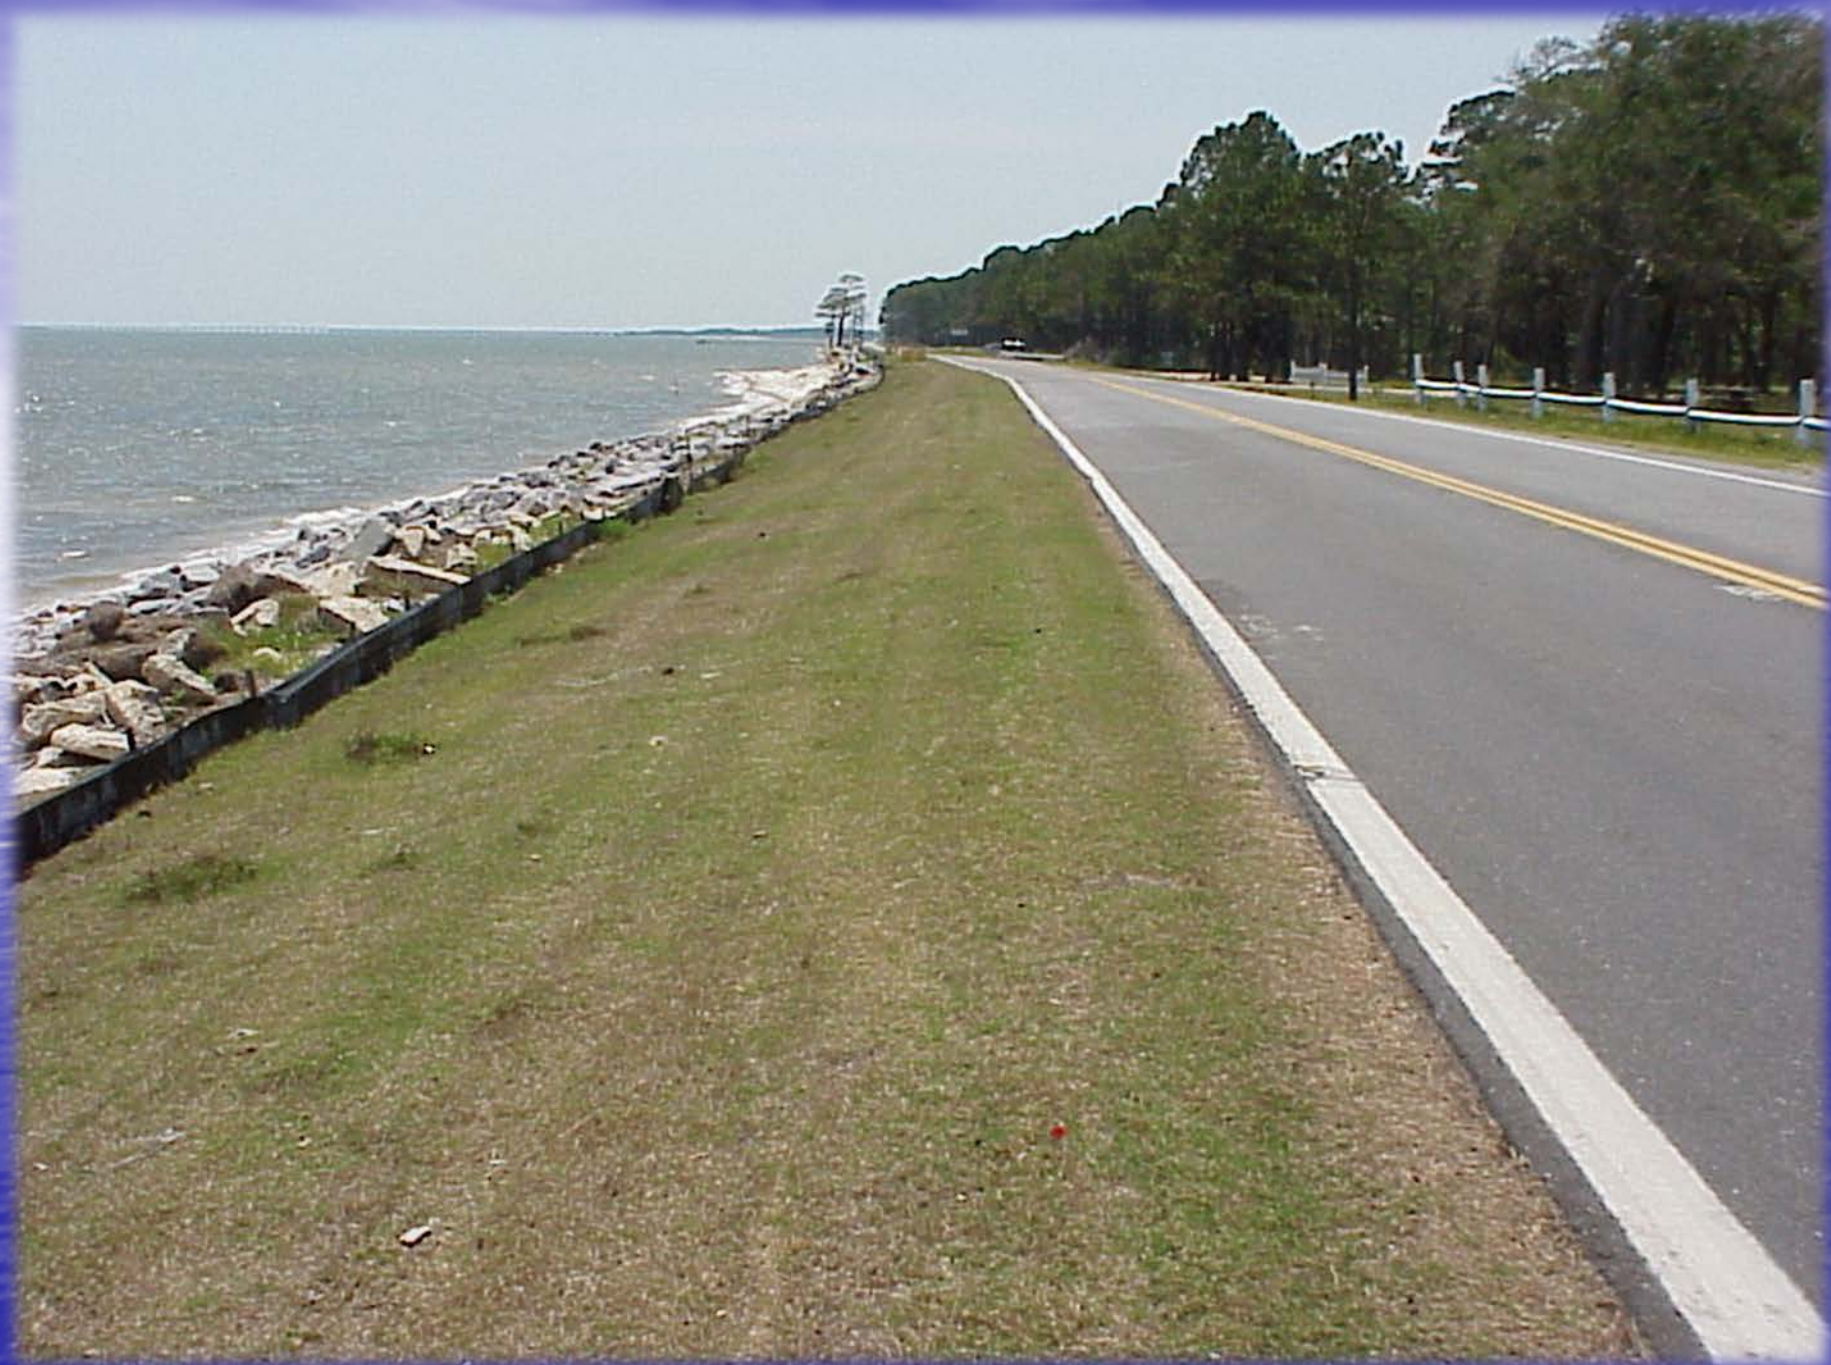
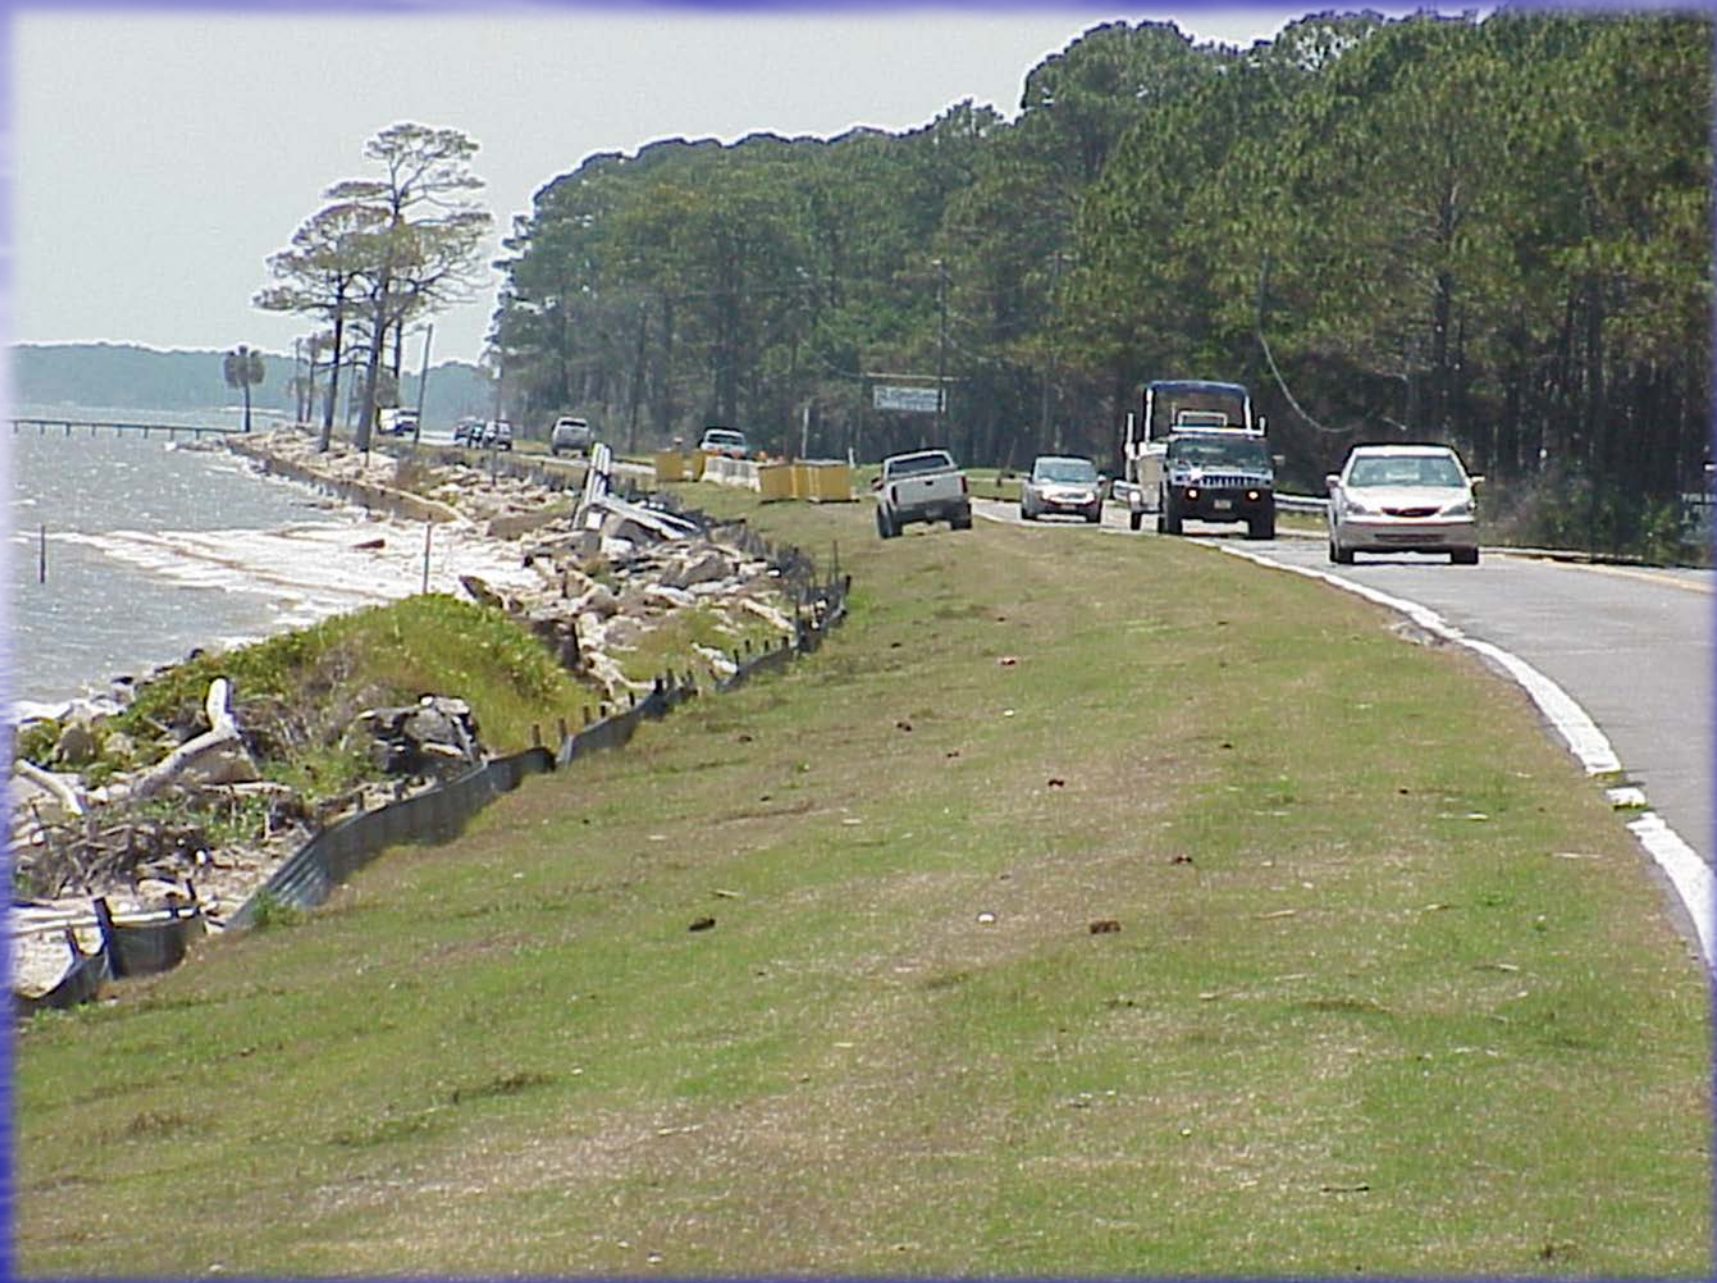
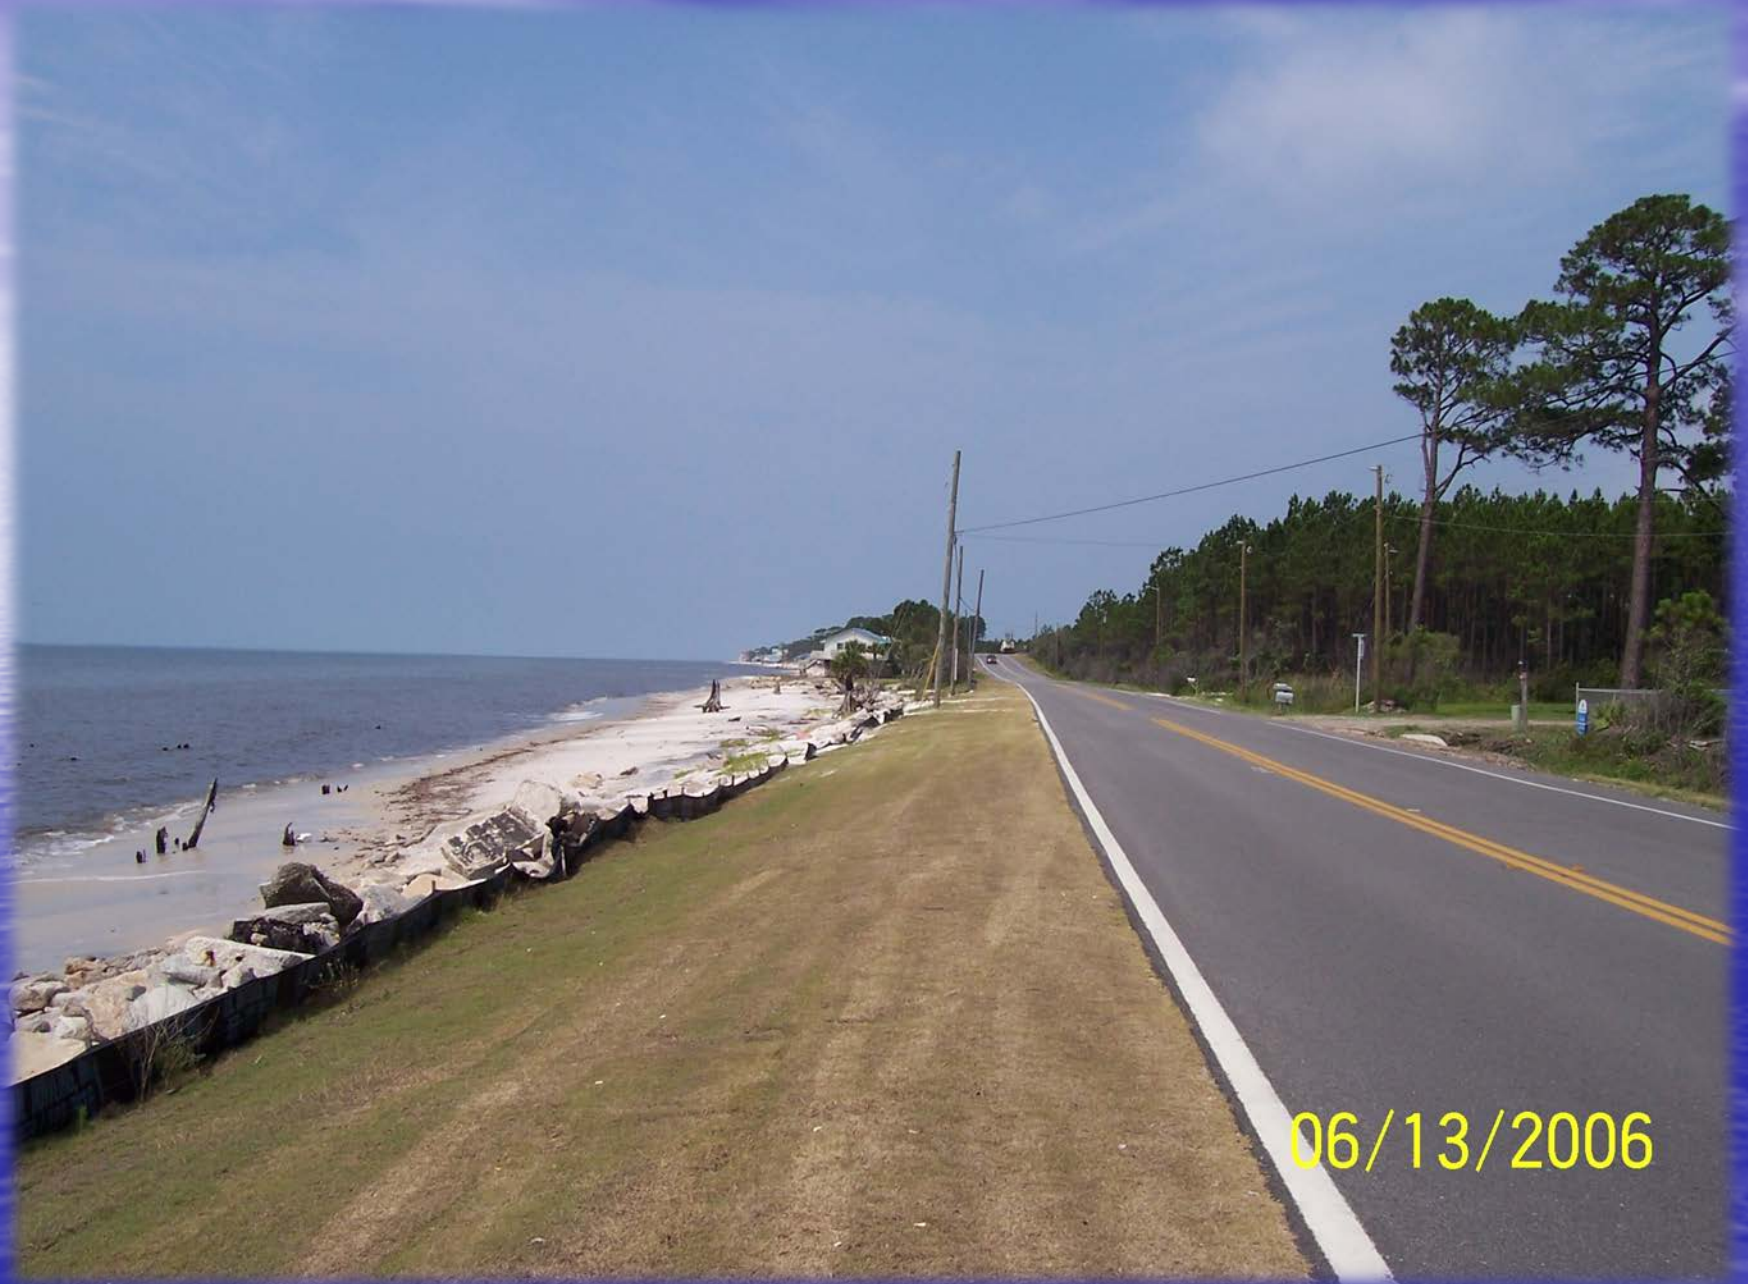
06/13/2006

**One year after placement showed no erosion or need for further repair. This area was hit by a tropical depression and a category 1 hurricane within 100 days after initial installation.**
